California Tree and Landscape Consulting, Inc.

July 29, 2024

PRE-DEVELOPMENT ARBORIST REPORT, TREE INVENTORY & PROTECTION PLAN

RE: 1 Corporate Way, APN 031-0051-019-0000; City of Sacramento Jurisdiction

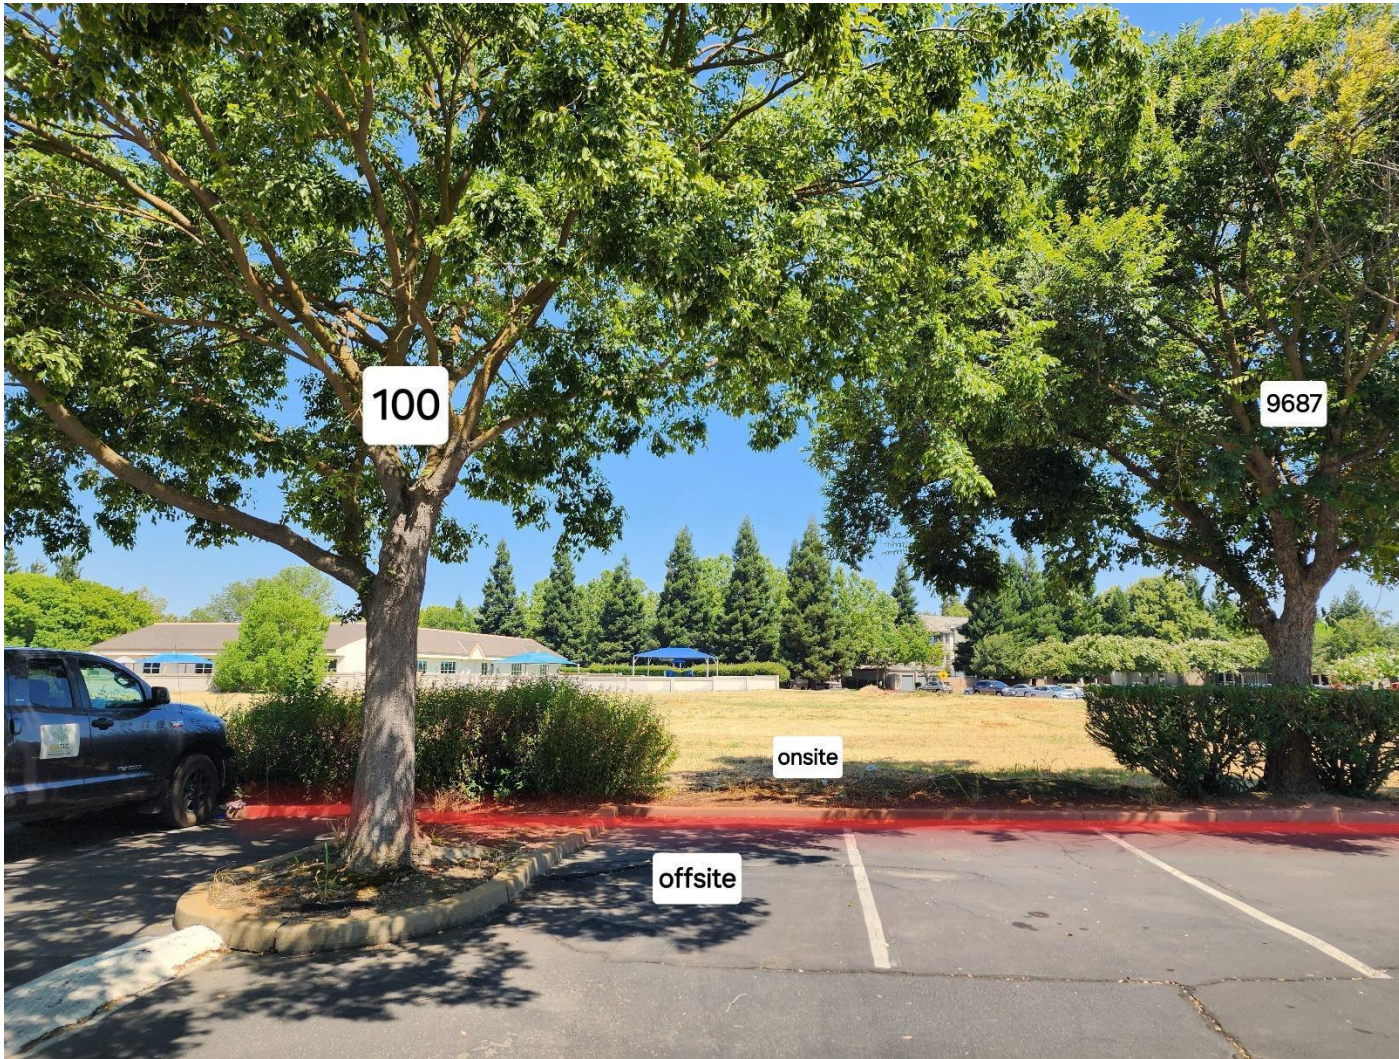
Tag #	Protected By Code	Heritage Tree	Offsite	Species Common Name	Species Botanical Name	DSH (in.)	Measured At (in.)	Canopy Radius (ft.)	Arborist Rating	Notes	Dvlpmnt Status	Mitigation measures
100			Yes	Chinese hackberry	<i>Celtis sinensis</i>	14.5	54	21	3-Minor Problems	fair flare, in growing strip into offsite parking lot. base approximately 14 feet offsite. crown overlaps property line by approximately 10 feet. fair crown balance and density. minor small branch die-back throughout.	No encroachment depicted.	N/A
101			Yes	Chinese pistache	<i>Pistacia chinensis</i>	7	54	17	3-Minor Problems	flare obscured, approximately 11 feet offsite. crown overextended west and overlaps property line west by approximately 8 feet, low crown west. slightly low crown density. fair crown balance. in offsite growing strip.	No encroachment depicted.	N/A
102			Yes	Chinese pistache	<i>Pistacia chinensis</i>	6.5	54	14	3-Minor Problems	fair flare, approximately 12 feet offsite, growing in parking lot strip offsite. unbalanced crown west, overlaps property line by approximately 5 feet. fair crown density.	No encroachment depicted.	N/A

9687				Chinese hackberry	<i>Celtis sinensis</i>	16	54	21	3-Minor Problems	fair flare. codominant at 7 and 9 feet. fair crown balance, overextended west crown. fair crown density.	Minor encroachment for driveway construction which falls slightly inside the critical root zone and landscaping directly under the tree.	Monitor excavation, may require irrigation.
9688				Chinese hackberry	<i>Celtis sinensis</i>	13.5	54	21	3-Minor Problems	fair flare. poor branch attachment southwest at 6 feet. fair crown balance and density. small branch die-back throughout	Minor encroachment for landscaping slightly within the crz.	Monitor excavation, may require irrigation.

Photo #1, Shows Trees #100, left (offsite) and #9687, right (onsite)

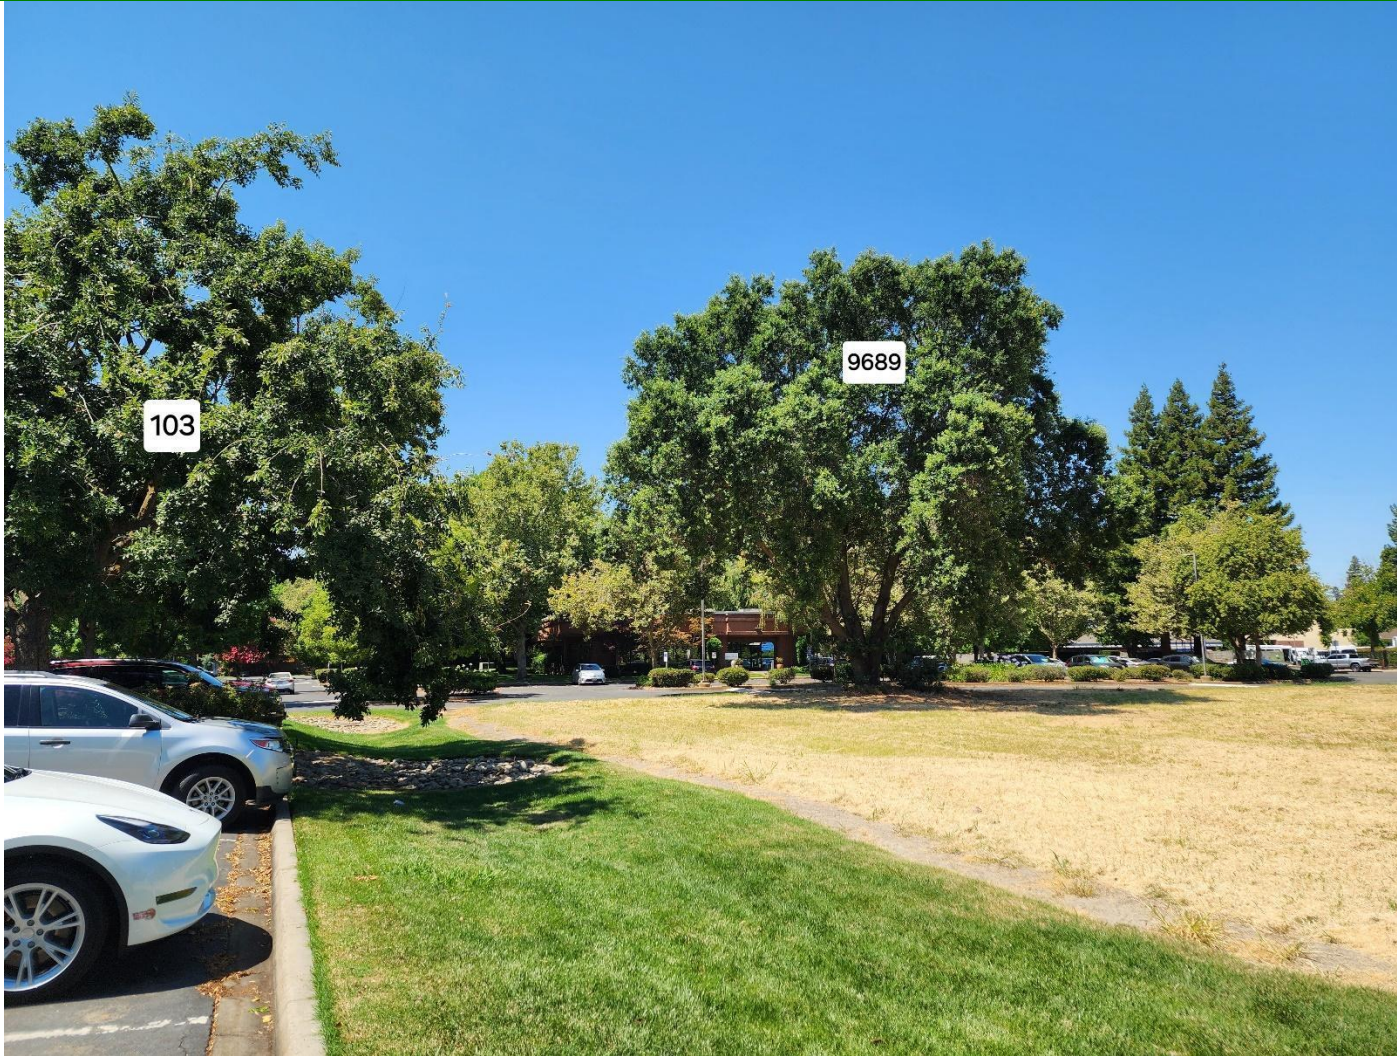
103			Yes	Chinese hackberry	<i>Celtis sinensis</i>	17	54	25	2-Major Structure or health problems	large elevated roots in parking lot growing strip. sunken sinuses around flare and trunk. crowded main stems, crossing and rubbing. unbalanced main crown stems lean heavy and low west. good crown	No encroachment depicted.	N/A

Photo #2, Shows Tree #103, left (offsite) and Heritage Tree #9689, right (onsite)

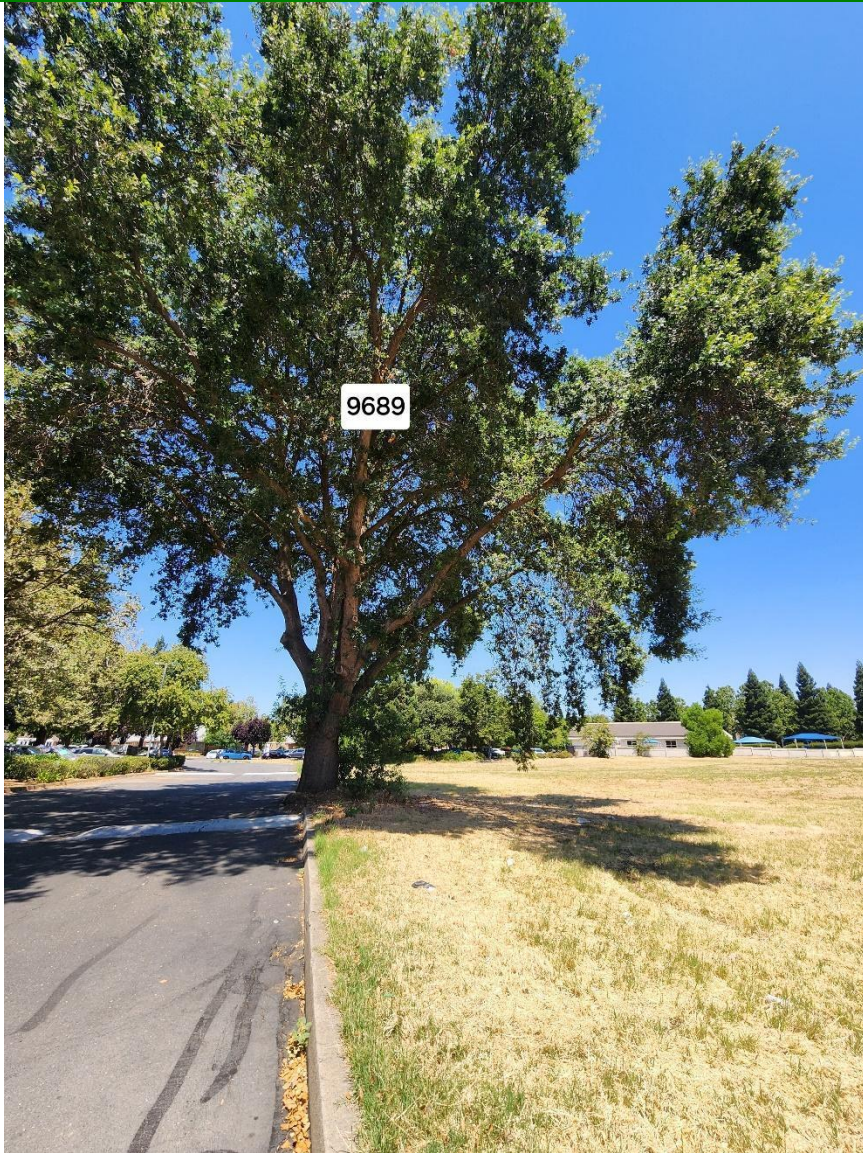
Photo #3, Shows Heritage Tree #9689

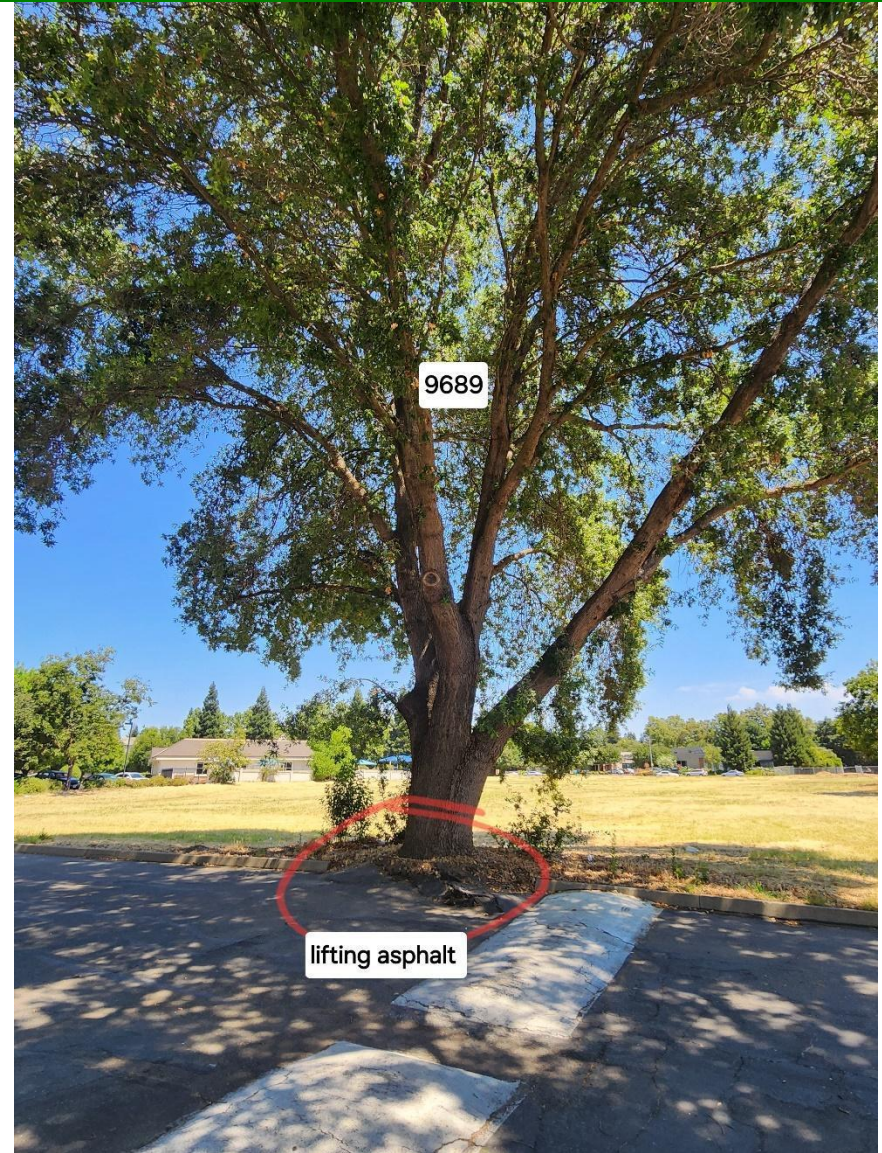
Tag #	Protected By Code	Heritage Tree	Offsite	Species Common Name	Species Botanical Name	DSH (in.)	Measured At (in.)	Canopy Radius (ft.)	Arborist Rating	Notes	Dvlpmnt Status	Mitigation measures
										crown. low crown north, west, and south. fair vigor.		
9689	Yes	Yes	Shared	Valley oak	<i>Quercus lobata</i>	40.3	54	37	3-Minor Problems	good flare, shallow roots lifting asphalt, possibly a shared tree. overlaps main stem southeast, inclusion at attachment union. fair crown balance, low crown northeast over lot. good crown density. good vigor.	Minor to moderate encroachment for water line installation and drive isle above water line. Building falls at edge of crz.	Monitor excavation, root prune as necessary. Excavation may require hydrovac equipment, begin with exploratory trench to determine root size (if any) at trench location. May require irrigation. The tree requires reduction pruning to reduce leverage and weight on overburdened branches. Install "permeable paving" surface within CRZ or install a piped aeration system beneath the hardscape.

Photo #4, Shows Heritage Tree #9689, lifting asphalt

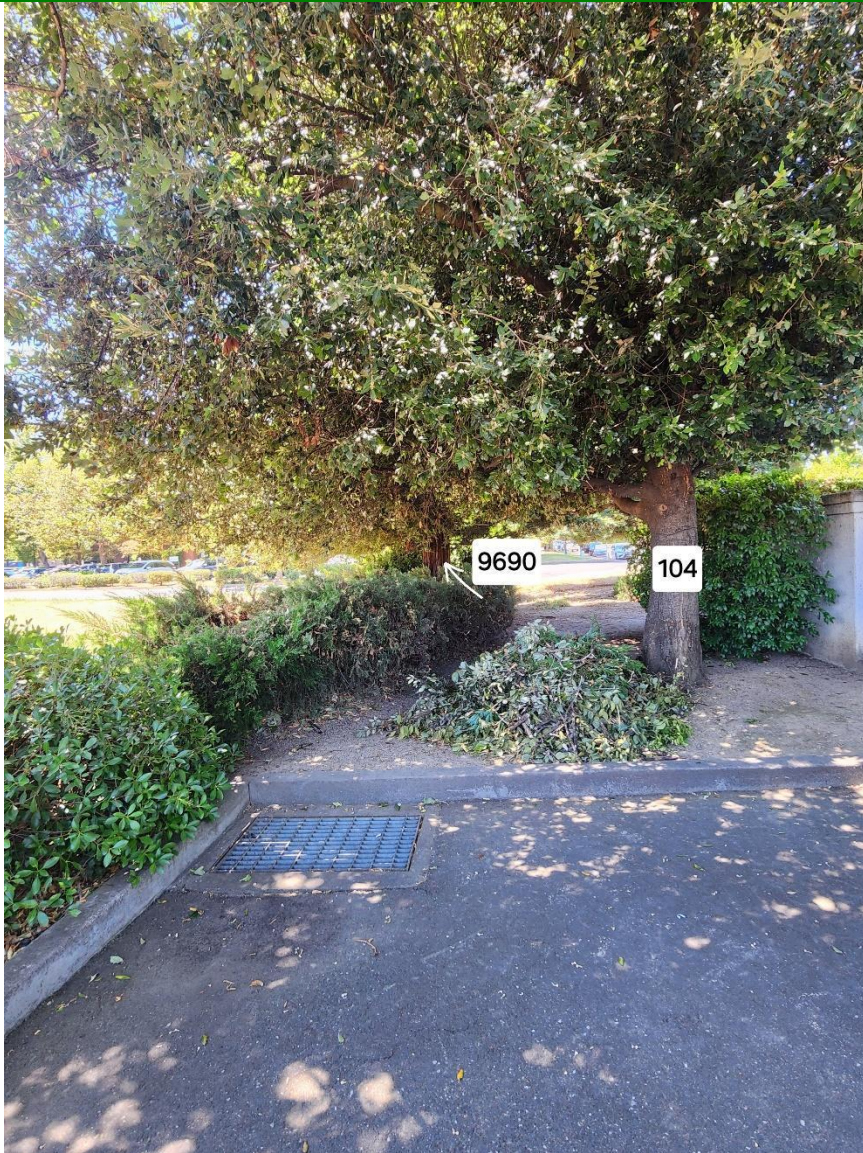
9690	Yes		Yes	Coast redwood	<i>Sequoia sempervirens</i>	24	54	13	3-Minor Problems	good flare. good overall balance and density. good vigor. my guess is that the tree is 7 feet offsite.	No encroachment depicted.	N/A
9691			Yes	Chinese hackberry	<i>Celtis sinensis</i>	13	54	21	3-Minor Problems	good flare, elevated roots. flush cuts on lower half of tree. moderate amount of dead branches up to 2 inches. fair crown balance and density.	Minor encroachment for driveway construction which falls slightly inside the critical root zone and landscaping directly under the tree.	Monitor excavation, may require irrigation.
9692			Yes	Chinese hackberry	<i>Celtis sinensis</i>	4	54	13	3-Minor Problems	fair flare, north flare touching wall on property	No encroachment depicted.	N/A

Photo #5, Shows Tree #9690, left (possibly offsite) and Tree #104, right (offsite)

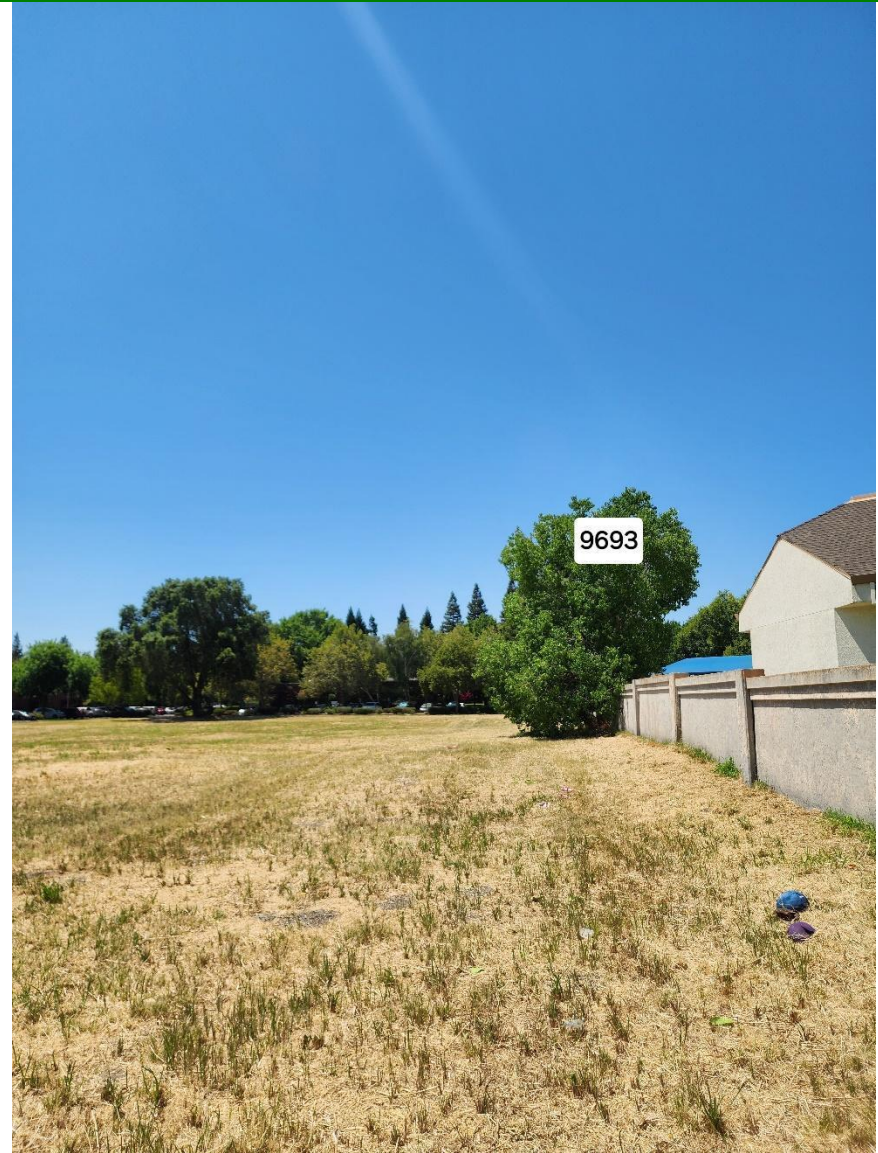
Tag #	Protected By Code	Heritage Tree	Offsite	Species Common Name	Species Botanical Name	DSH (in.)	Measured At (in.)	Canopy Radius (ft.)	Arborist Rating	Notes	Dvlpmnt Status	Mitigation measures
										line. low crown, fair crown balance and density.		
9693			Yes	Chinese tallow tree	<i>Triadica sebifera</i>	13	54	16	2-Major Structure or health problems	unbalanced base, touching wall on property line. swollen lower trunk with dead branches. low mature lateral branches, low crown. fair crown balance and density.	Minor encroachment for driveway construction which falls slightly inside the critical root zone and landscaping directly under the tree.	Monitor excavation, root prune as necessary. May require irrigation.
9694	Yes		Yes	Coast redwood	<i>Sequoia sempervirens</i>	28.5	54	15	3-Minor Problems	good flare, approximating tree is 4 feet offsite. good overall balance and foliage health. low lateral branches west over property line. good vigor.	Minor encroachment for driveway construction which falls at the critical root zone and landscaping under the tree.	Monitor excavation, may require irrigation.

Photo #6, Shows Tree #9693
