**PHASE I ENVIRONMENTAL
SITE ASSESSMENT REPORT**

**CENTERPOINTE AT NATOMAS
2200-2250 Del Paso Road
Sacramento, California 95834**

**Date Issued: February 16, 2006
LAC Project Number 06-34635.1**

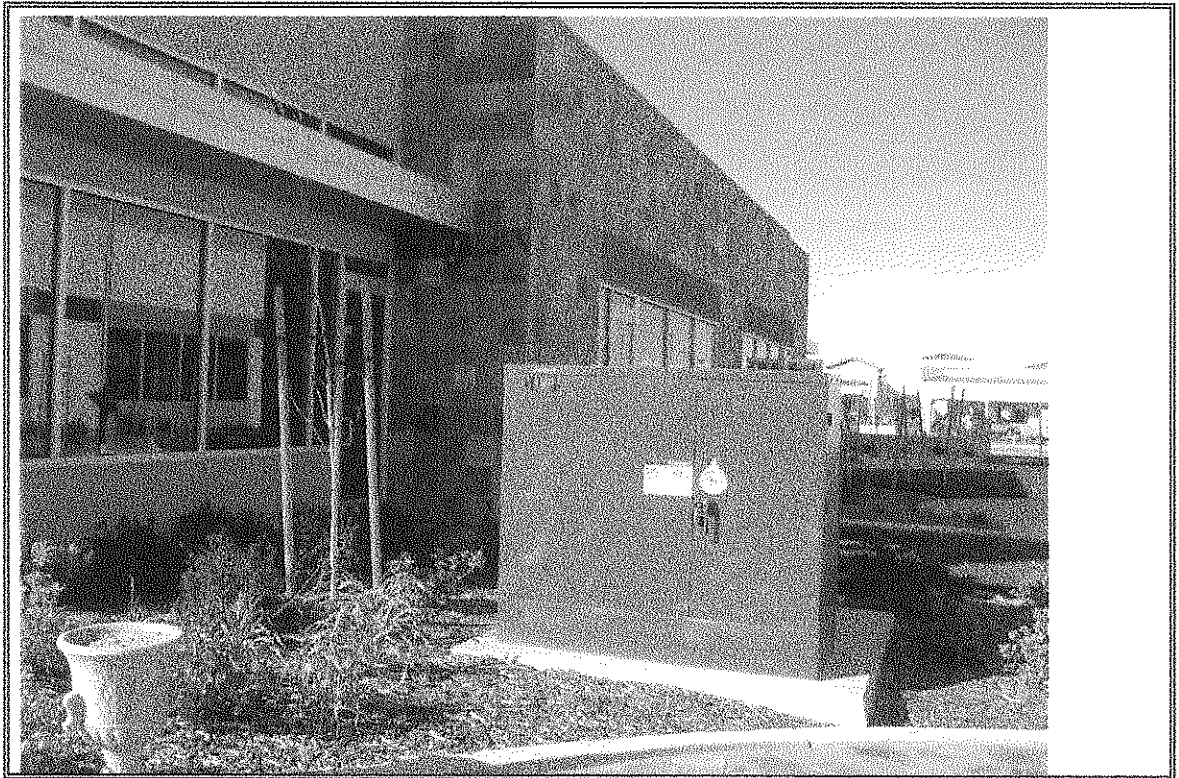
LAC observed two pad-mounted electrical transformers on the Property. The units are situated outside the southeast corner of Building 2250 and 2210. The units were labeled as to contain Envirotamp FR3 Fluid and to be owned and operated by SMUD. No indication of staining, leaks or fire damage was observed on or around the bases of the two units. Based on the initial development of the Property in 2005, both units are

considered "Non-PCB" transformers. Additionally, LAC contacted Customer Service for SMUD (telephone conversation of February 13, 2005) who confirmed the SMUD ownership and operational responsibility. No other electrical equipment expected to contain PCBs was observed on the Property during LAC's reconnaissance.

Photograph Number 14 Transformer east of 2250 Building
