# Arborist Survey Report

# Silver Eagle 6

City of Sacramento, Sacramento County, California

May 2024

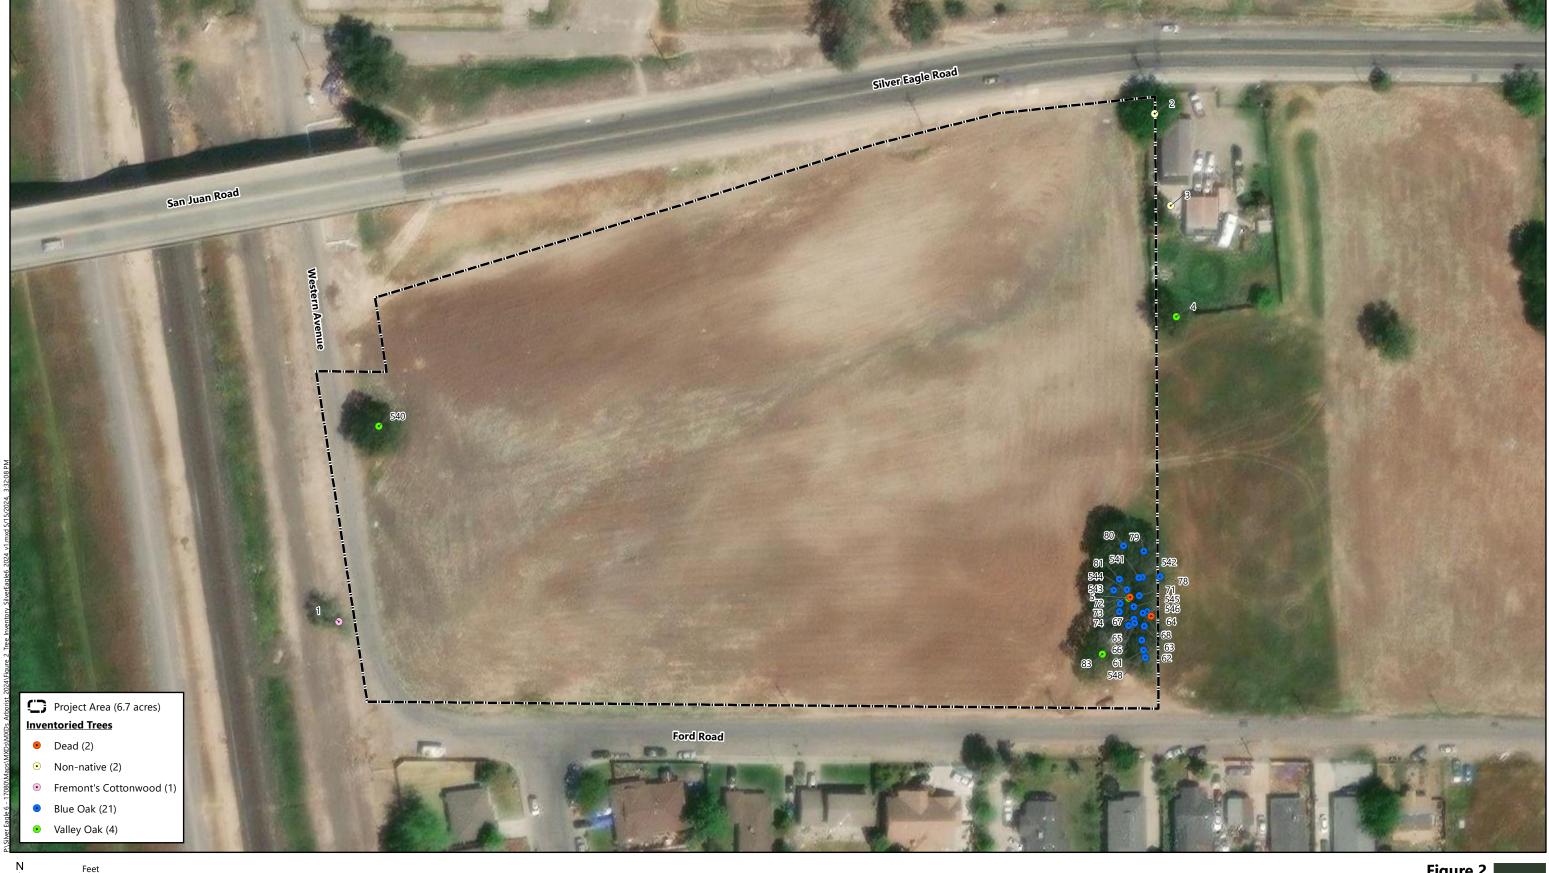
Figure 2 Tree Inventory Map

Ms. Snider surveyed 30 trees, 23 of which were alive and located within the Study Area. Of these, only 13 met the Tree Ordinance size threshold and are considered Protected Trees under the Tree Ordinance. These include two Valley oak (*Quercus lobata*) trees and 11 blue oak (*Quercus douglasii*) trees. The data is summarized in **Attachment A** and a map of the inventoried trees is included as **Figure 2**. The cumulative DSH of the 13 Protected Trees documented within the Study Area is 281.6 inches and is shown in **Table 1** below along with tree health.
