Draft
**Existing Conditions and Assessment Report
and Stream Corridor Management Plan
for Arcade Creek, Sacramento County, California**

October 2007

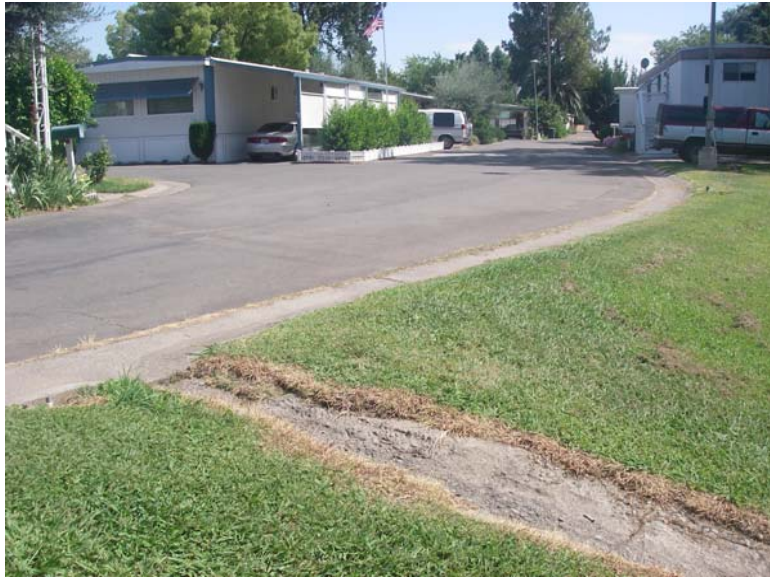
Paved Swale on Left Bank Terrace (Reach 11)

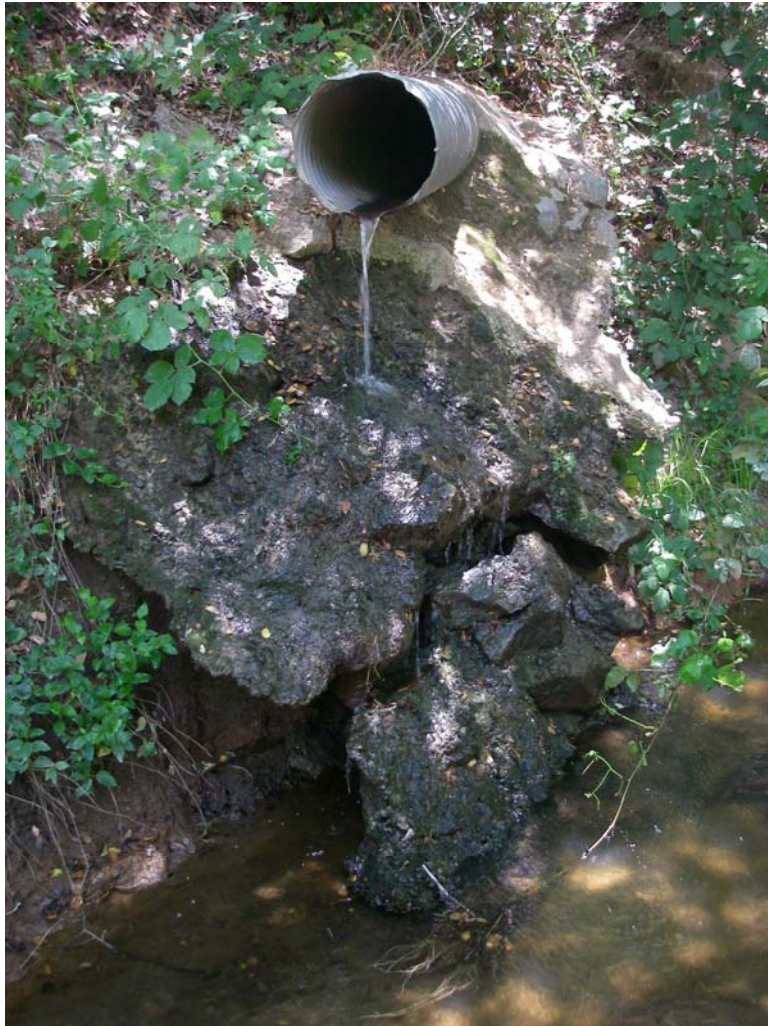
Eroding Pipe on Right Bank (Reach 15)

The existing pipe outfall would be trimmed back to either allow for an extension of the pipe outfall in the downward direction (if the pipe outfall exceeds more than a few feet in height) or to lay flush with the bank. In both cases, boulders would be installed in the channel bed against the bank to dissipate the energy of the water exiting the pipe outfall. If the pipe extension method were used, then the extension would need to be properly secured to the bank with the outlet located approximately 2 feet above the low-flow water surface. The outlet would also be supported by the boulders placed in the channel bed.

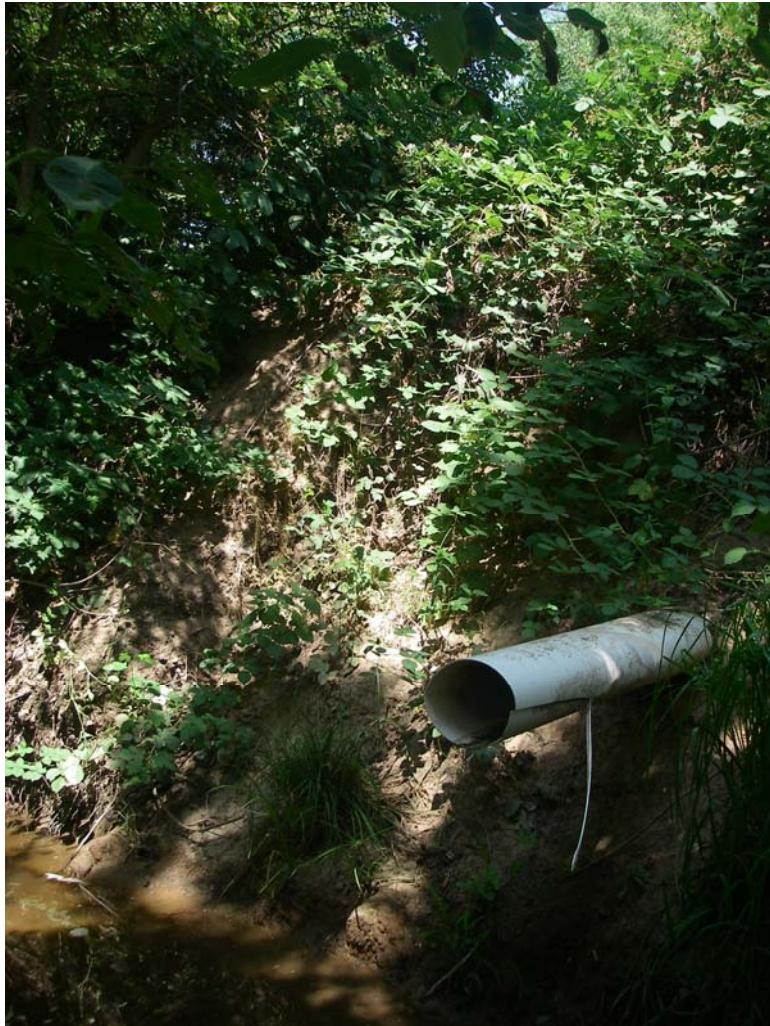
Eroding Pipe on Right Bank (Reach 12)

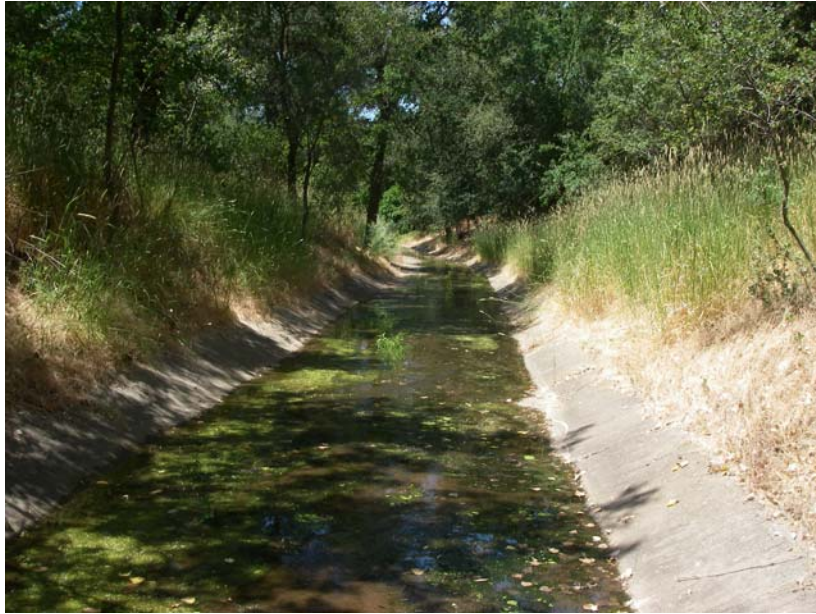
Concrete-Lined Channel (Reach 19)

To remove a concrete-lined channel, the concrete needs to be manually removed and properly disposed of. The channel then needs to be restored to a natural condition and stabilized. Natural fill for both the channel bed and the bank needs to be imported. Specific habitat units (e.g., pools, riffles, and runs) need to be properly excavated and stabilized, often with grade control structures. Clean gravels (i.e., gravels with a low fine sediment matrix) may need to be incorporated for riffle habitat, if desirable. Grade control structures may need to be incorporated into the overall channel design in order to lessen the likelihood of incision. Revegetation efforts need to occur on the banks, and the connection to the floodplain needs to be constructed properly. BMPs to limit erosion after the initial restoration of the reach need to be implemented and monitored on a regular basis.

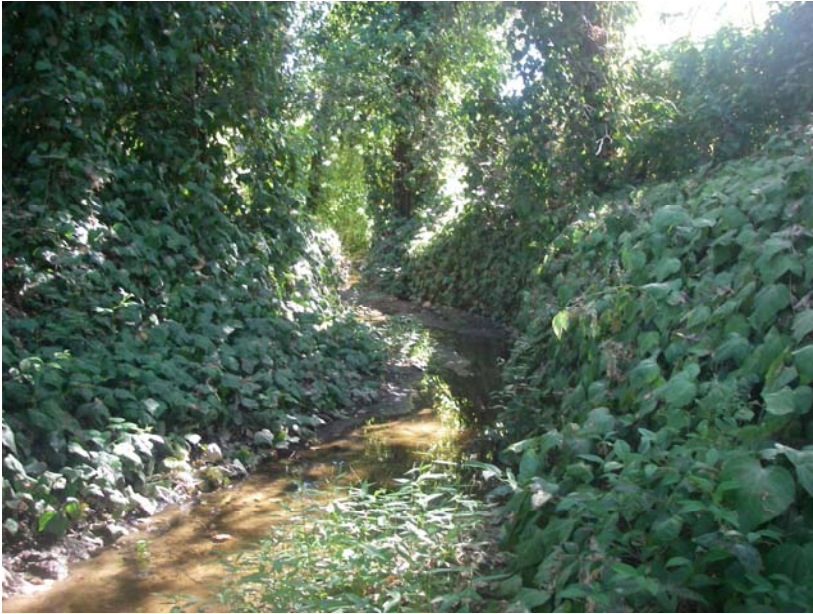
English Ivy Dominating Channel

Before removing invasive nonnative species, particularly dense monoculture stands of vines and groundcover, it should be determined if the removal of the vegetation would result in channel or floodplain instability. Revegetation with native species following initial removal efforts of invasive nonnative species could be performed at all of the removal sites to promote the establishment of native species before nonnative species can reestablish. The establishment of native species will require the purchase, installation, and maintenance of plant material. Specific revegetation and maintenance plans would be developed.

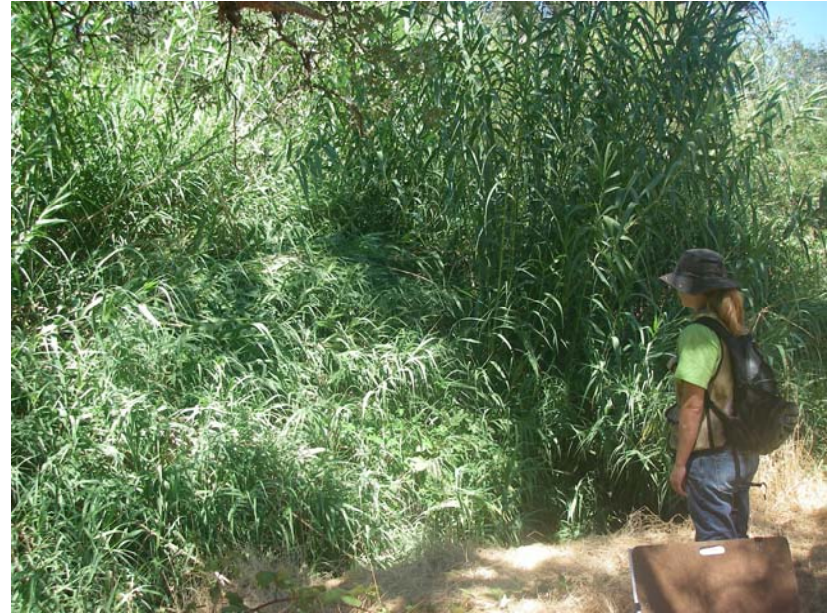
Large Giant Reed Stand on Cripple Creek near Sunrise Boulevard

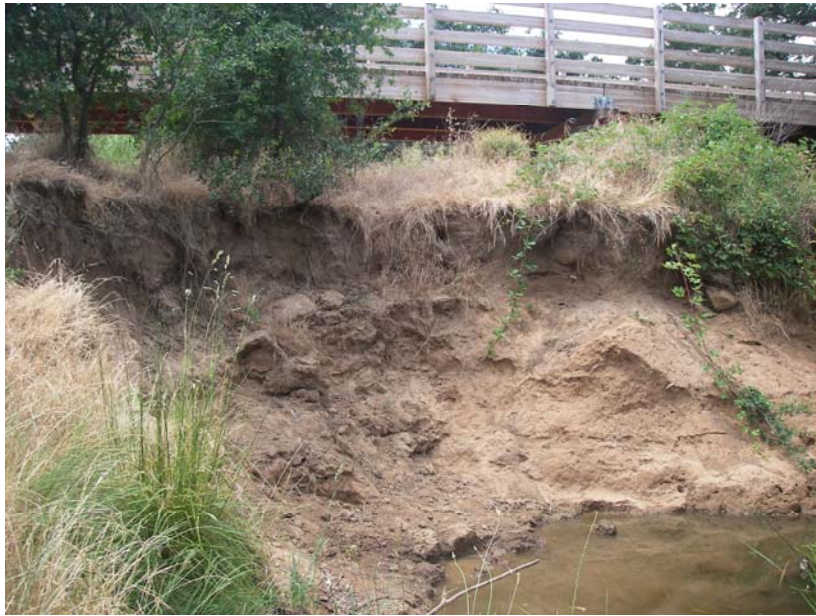
Severe Bank Erosion on Left Bank Adjacent to Pedestrian Bridge (Reach 16)

In general, bank stabilization can be divided into two main categories: biotechnical stabilization and hardscaping. Biotechnical stabilization involves the use of natural materials (e.g., vegetation, large woody material, etc.) to stabilize banks. Often, these natural materials are placed on the unstable bank once the bank has been re-graded to a less steep slope that will decrease the likelihood of erosion due to mass failure. Hardscaping involves the use of rip-rap, concrete, gabions, and other hard methods for stabilizing banks. These methods are not as environmentally sensitive as biotechnical stabilization methods and typically are only used when the latter approach is not feasible.

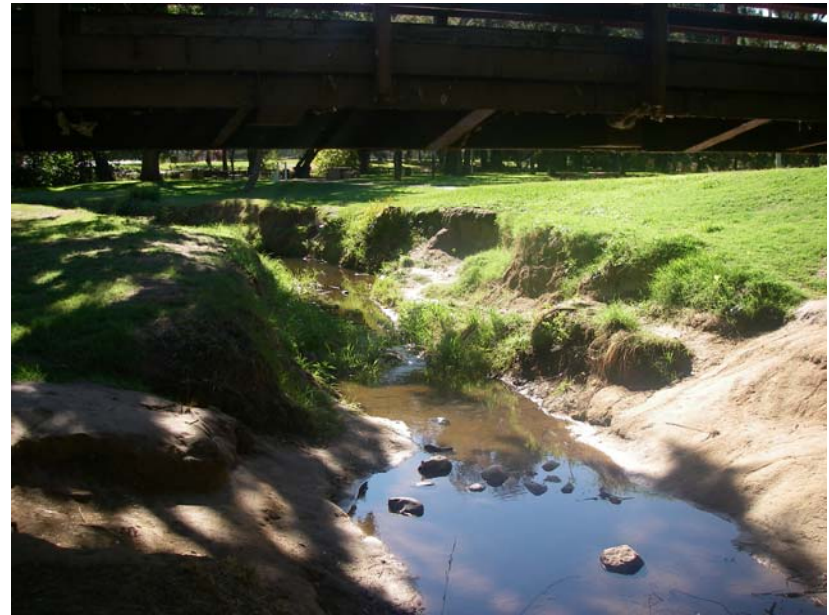
Eroding Bank near Bridge in Rusch Regional Park (Reach 26)

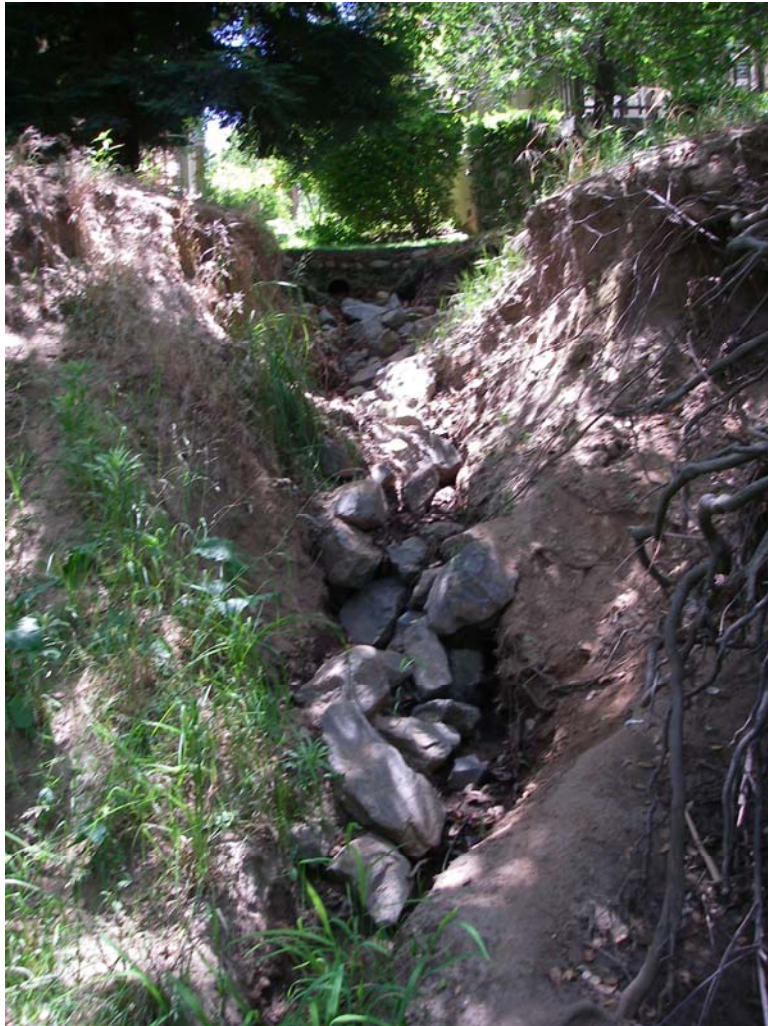
Eroding Swale (Reach 15)

The banks of the swale would be graded to a stable slope (e.g., 2:1). Installation of a grade control structure at the headcut in the swale is the second step in the construction process. New boulders would be placed on the channel bed of the swale. Lastly, revegetation of the banks would occur.

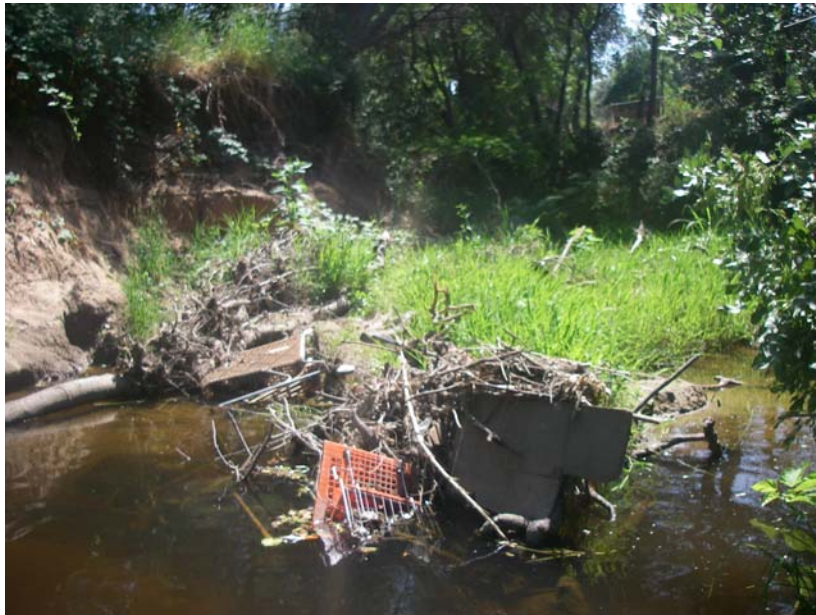
Debris Jam (Reach 11)

Methods for removal of debris jams and flow obstructions are straightforward. Personnel need access to the creek and need to employ the necessary tools and equipment to fully remove the debris jam or flow obstruction. In some cases, debris jams can be removed by hand labor to minimize disturbance to the surrounding area. Based on the field survey, many of the debris jams and all flow obstructions will need to be removed using equipment.

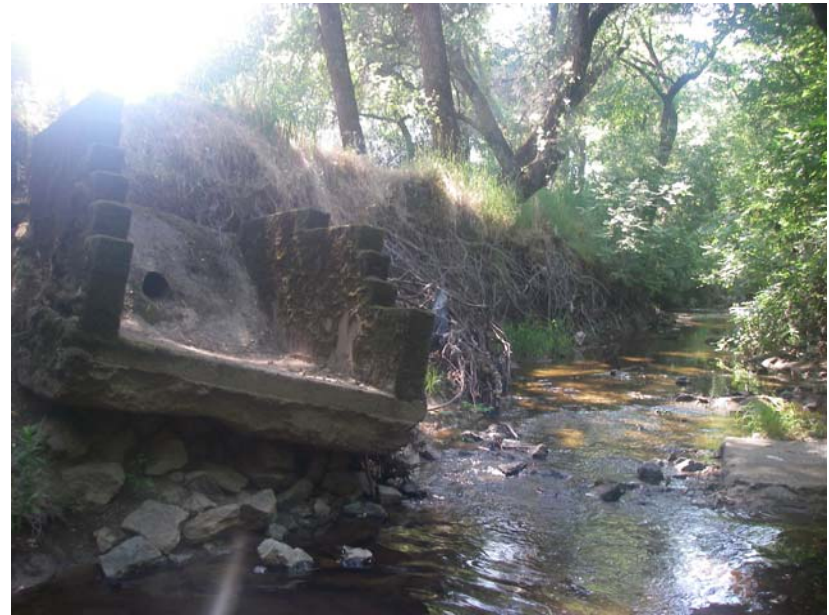
Flow Obstruction on Left Bank (Reach 11)

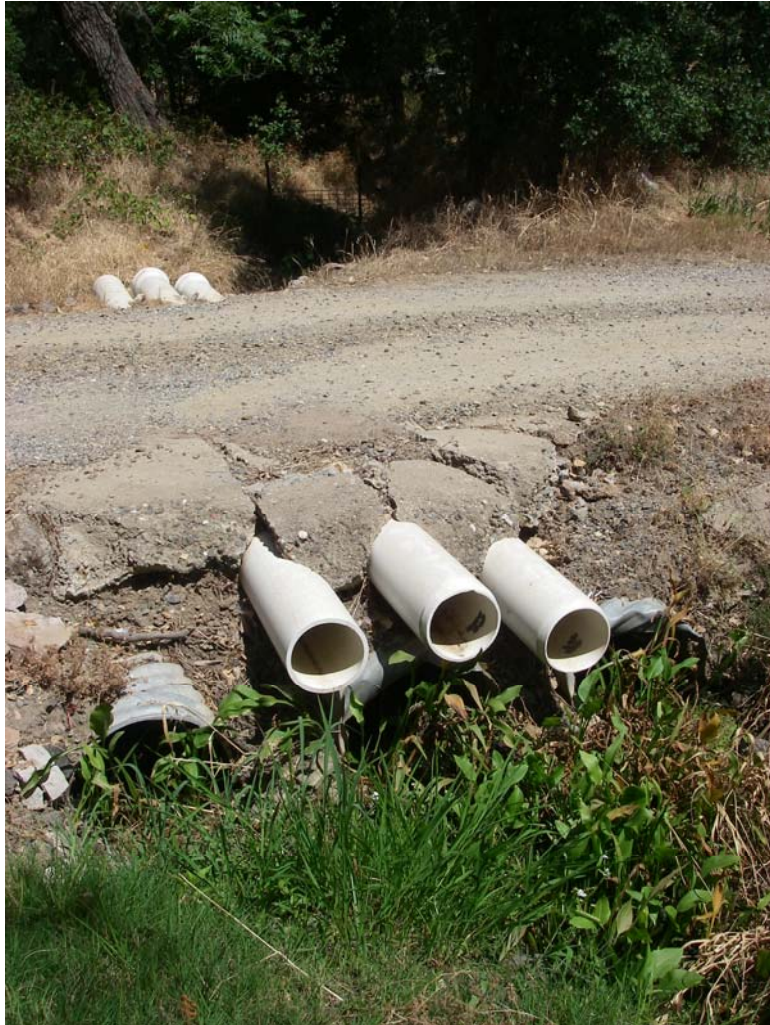
Sediment and Vegetation Upstream and Downstream of Creek Crossing (Reach 21)

Removal of sediment and vegetation at creek crossings requires manual excavation (by hand and/or with machinery). Once proper access is determined, this activity is relatively easy to implement. It is recommended that all non-native vegetation be fully removed within at least 20 feet of the creek crossing (in both the upstream and downstream directions), and that the sediment be excavated and removed to a depth that resembles the average of the channel bottom elevation 50 feet upstream and downstream of the creek crossing.
