ARCADE CREEK FEASIBILITY STUDY

Prepared for:

Department of Parks and Recreation
City of Sacramento
1023 J Street, Room 200
Sacramento, California

November 15, 2002

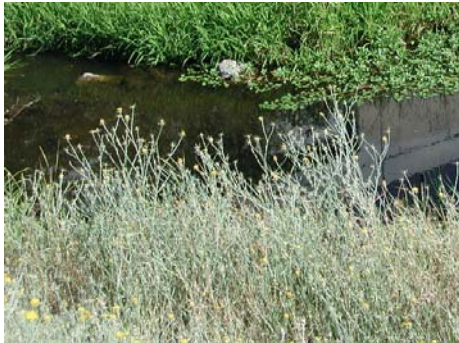
Yellow Star Thistle near Arcade Creek

grazing. Where possible, small infestations of these species should be removed to prevent them from spreading.

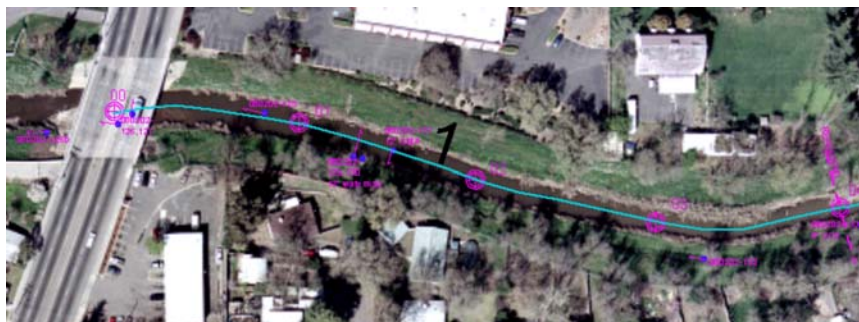
126-132, 126b

The stream channel in this reach has low sinuosity. Streambed is mostly silt with some organic debris but no sand, gravel, cobbles, or boulders. The banks are well laid back with a bankfull width almost five times the observed width. The available floodplain is 105 feet wide. Water velocity is very slow at .2 feet per second. There is no canopy cover. Stream structure is poor with no riffles occurring in this reach.

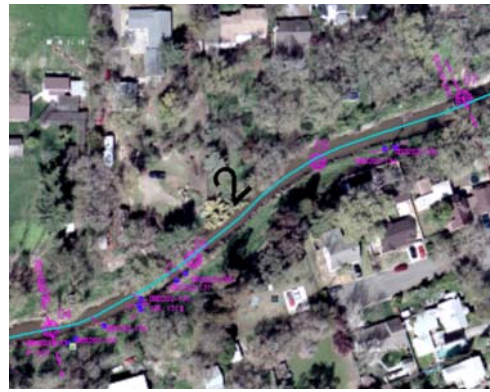
Photographs: 080202: 125, 133-140, 137b

The stream channel has medium sinuosity. Streambed is mostly silt with some organic debris and no sand, gravel, cobbles, or boulders. Bankfull width is slightly over two times the observed width. The left bank has a ten-foot terrace while the right bank is cut at points and has sandbags scattered along it. Obstructions in the stream include *Arundo* clusters, which in places block almost the entire channel. Available floodplain width is 60 feet. The creek is very slow moving with a velocity of .2 feet per second and has a canopy cover of 10%. Stream structure is poor, being one continuous pool.

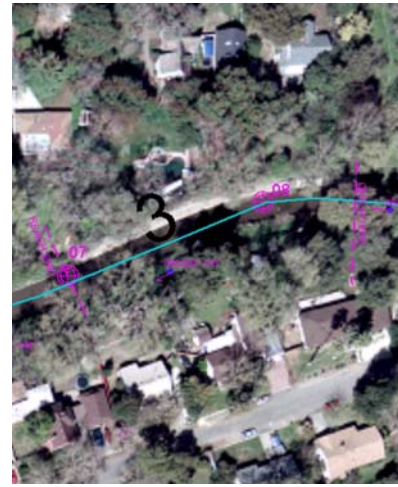
Starting Stationpoint: 7.0
Ending Stationpoint: 8.3
Photographs: 080202: 141

The stream channel in this reach has a low sinuosity. The streambed is made up exclusively of silt. The bankfull width is 2.5 times the observed width. Overall bank condition is poor. The left bank is steep with a vegetated access road while the right bank is steep and covered with gunite to a boundary fence. The available floodplain is fairly narrow at 50 feet wide. Water moves very slowly through this reach at a velocity of .2 feet per second. Canopy cover is only 5%. Stream structure is poor, with no riffles in this reach.

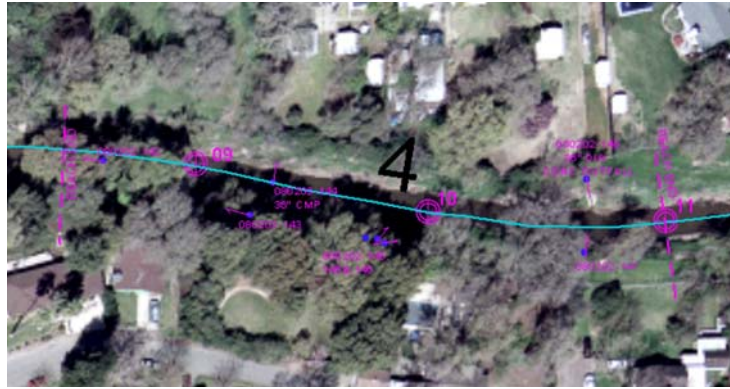
145b

The stream channel in this reach has very low sinuosity. Streambed is mostly silt with some organic debris and no sand, gravel, cobbles, or boulders. At four times the observed width, the bankfull width is good. Overall condition of banks is poor with the left bank covered with concrete rip rap and terraced with an access road that is covered in herbaceous vegetation. The right bank is very steep and covered with grass and weeds. Available floodplain width is 80 feet. The creek is slow moving with a velocity of .2 feet per second and has a channel canopy cover of 20%. Stream structure is poor, consisting of one continuous pool.

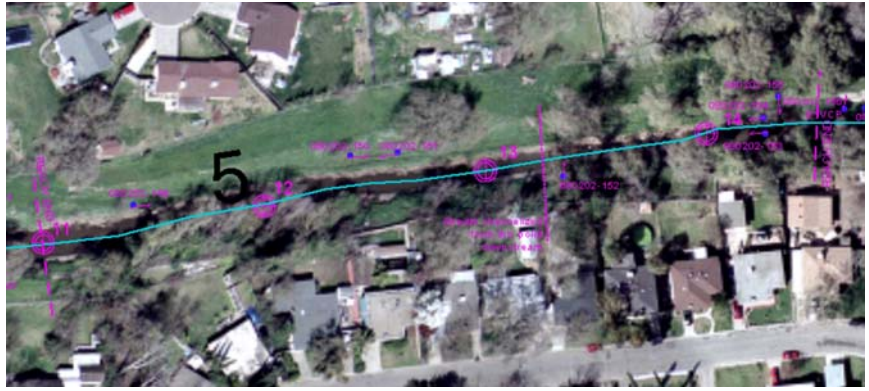
Starting Stationpoint: 11.0
Ending Stationpoint: 14.5
Photographs: 080202: 149-155

The stream channel in this reach has a low sinuosity. The streambed consists mostly of streambed silt with some organic debris. The bankfull width is excellent at five times the observed width. However, bank conditions are poor. The left bank is eroding and covered with concrete for one third of the reach. There is a 16-foot wide terrace on the right bank. The available floodplain is 60 feet wide. The stream is very slow moving at .2 feet per second and has a channel canopy cover of 50%. Stream structure is poor with only one large pool and no riffles.

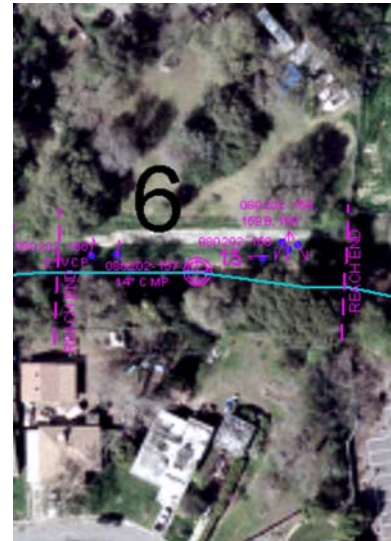
Photographs: 080202: 156-160, 159b

The stream channel in this reach has low sinuosity. The streambed consists mostly of silt with some organic debris. The bankfull width is five times the observed width. Both the left and right banks are coated with gunite, although the left bank is eroded. The width of the available floodplain is 60 feet. The stream flows slowly at .5 feet per second. There is 70% channel canopy cover. Stream structure is poor consisting of only one large pool.

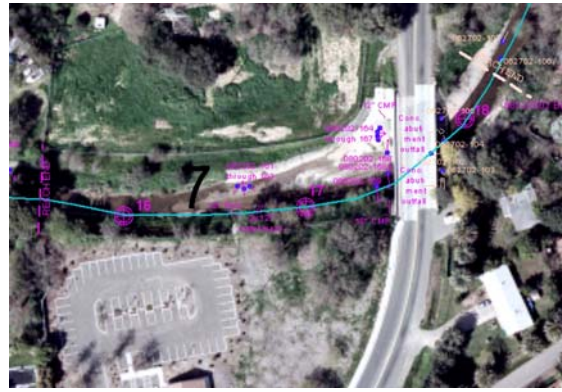
080202: 161-169, 168b

The stream channel in this reach has low sinuosity. The stream is entirely contained in an asphalt channel. There is a small amount of organic debris in the streambed. The bankfull width is five times the observed width. Both banks are asphalt reinforced. Seven bridge piers obstruct the creek. Available floodplain width is 60 feet. The stream is very slow moving with a velocity of .2 feet per second. Only 5% of the channel has canopy cover. The stream structure is poor, consisting of one large pool and no riffles. Observed depth is very shallow (<1').

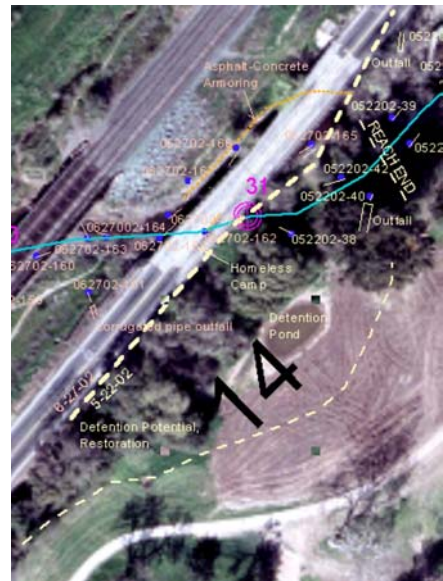
Sinuosity of the channel in this area is moderate, and the reach has some structure: the team noted three riffles but no pools. Observed stream width is 25 feet, bankfull width is 60 feet, and floodplain width is 90 feet. Flow is moderate at 2 fps. Bridge piers from Roseville Road partially obstruct the flow. It is very likely that the bridge abutments constrain peak flows and contribute to the upstream flooding problems. This is exacerbated by the two bridge crossings not being perpendicular to the channel reach.

Bank conditions are poor due to concrete armoring. Streambed material is primarily silt, although cobbles, organic debris, gravel and sand were also noted. The bridge provides a 40% canopy over the stream. Other than the bridge, there is little cover.
