Aquatic Resources Delineation Report

Silver Eagle 6

Sacramento, CA

Sacramento County, California
December 2017

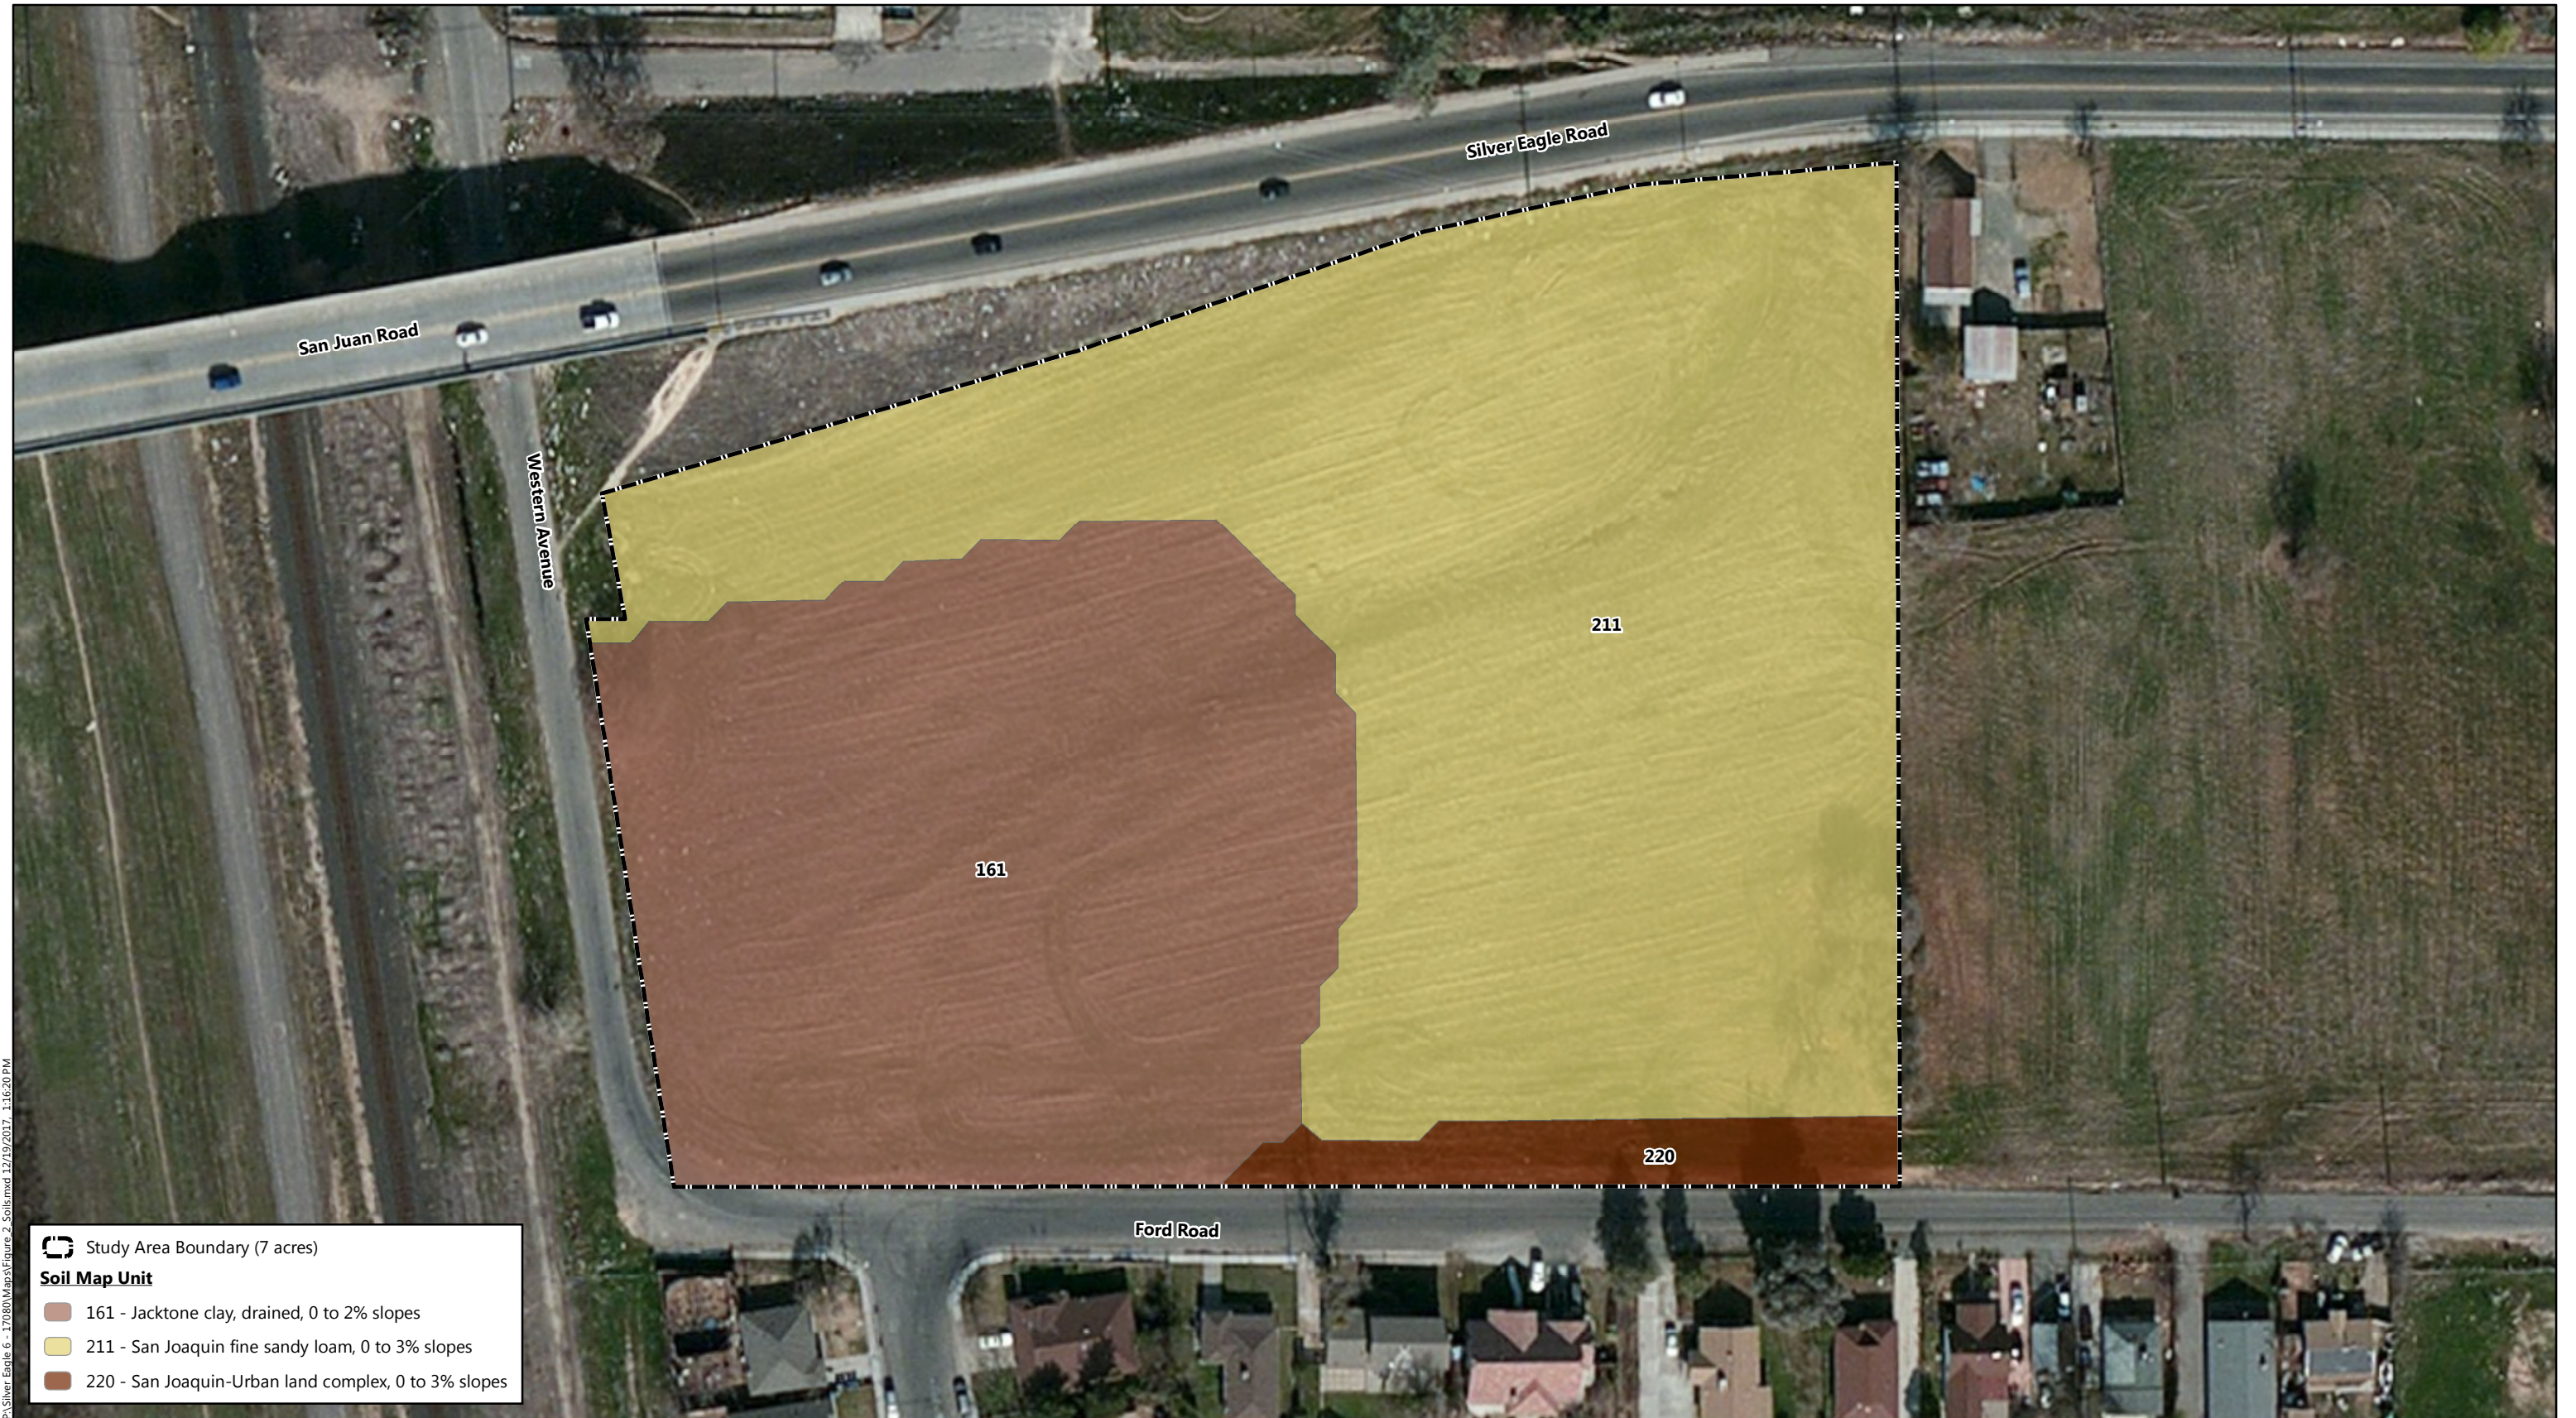
Figure 2
Natural Resources Conservation
Service Soils

According to the Natural Resources Conservation Service (NRCS) Soil Survey Database (NRCS 2017), three soil mapping units occur within the Study Area (**Figure 2**): (161) Jacktone clay, drained, 0 to 2% slopes; (211) San Joaquin fine sandy loam, 0 to 3% slopes; and (220) San Joaquin-Urban land complex, 0 to 3 % slopes. Jacktone clay is listed by the NRCS as a hydric soil (NRCS 2017), as well as a nonsaline to very slightly saline soil. The San Joaquin soils are not listed as hydric, nor do they typically contain hydric minor components.

161 - Jacktone clay, drained, 0 to 2% slopes

211 - San Joaquin fine sandy loam, 0 to 3% slopes

220 - San Joaquin-Urban land complex, 0 to 3% slopes

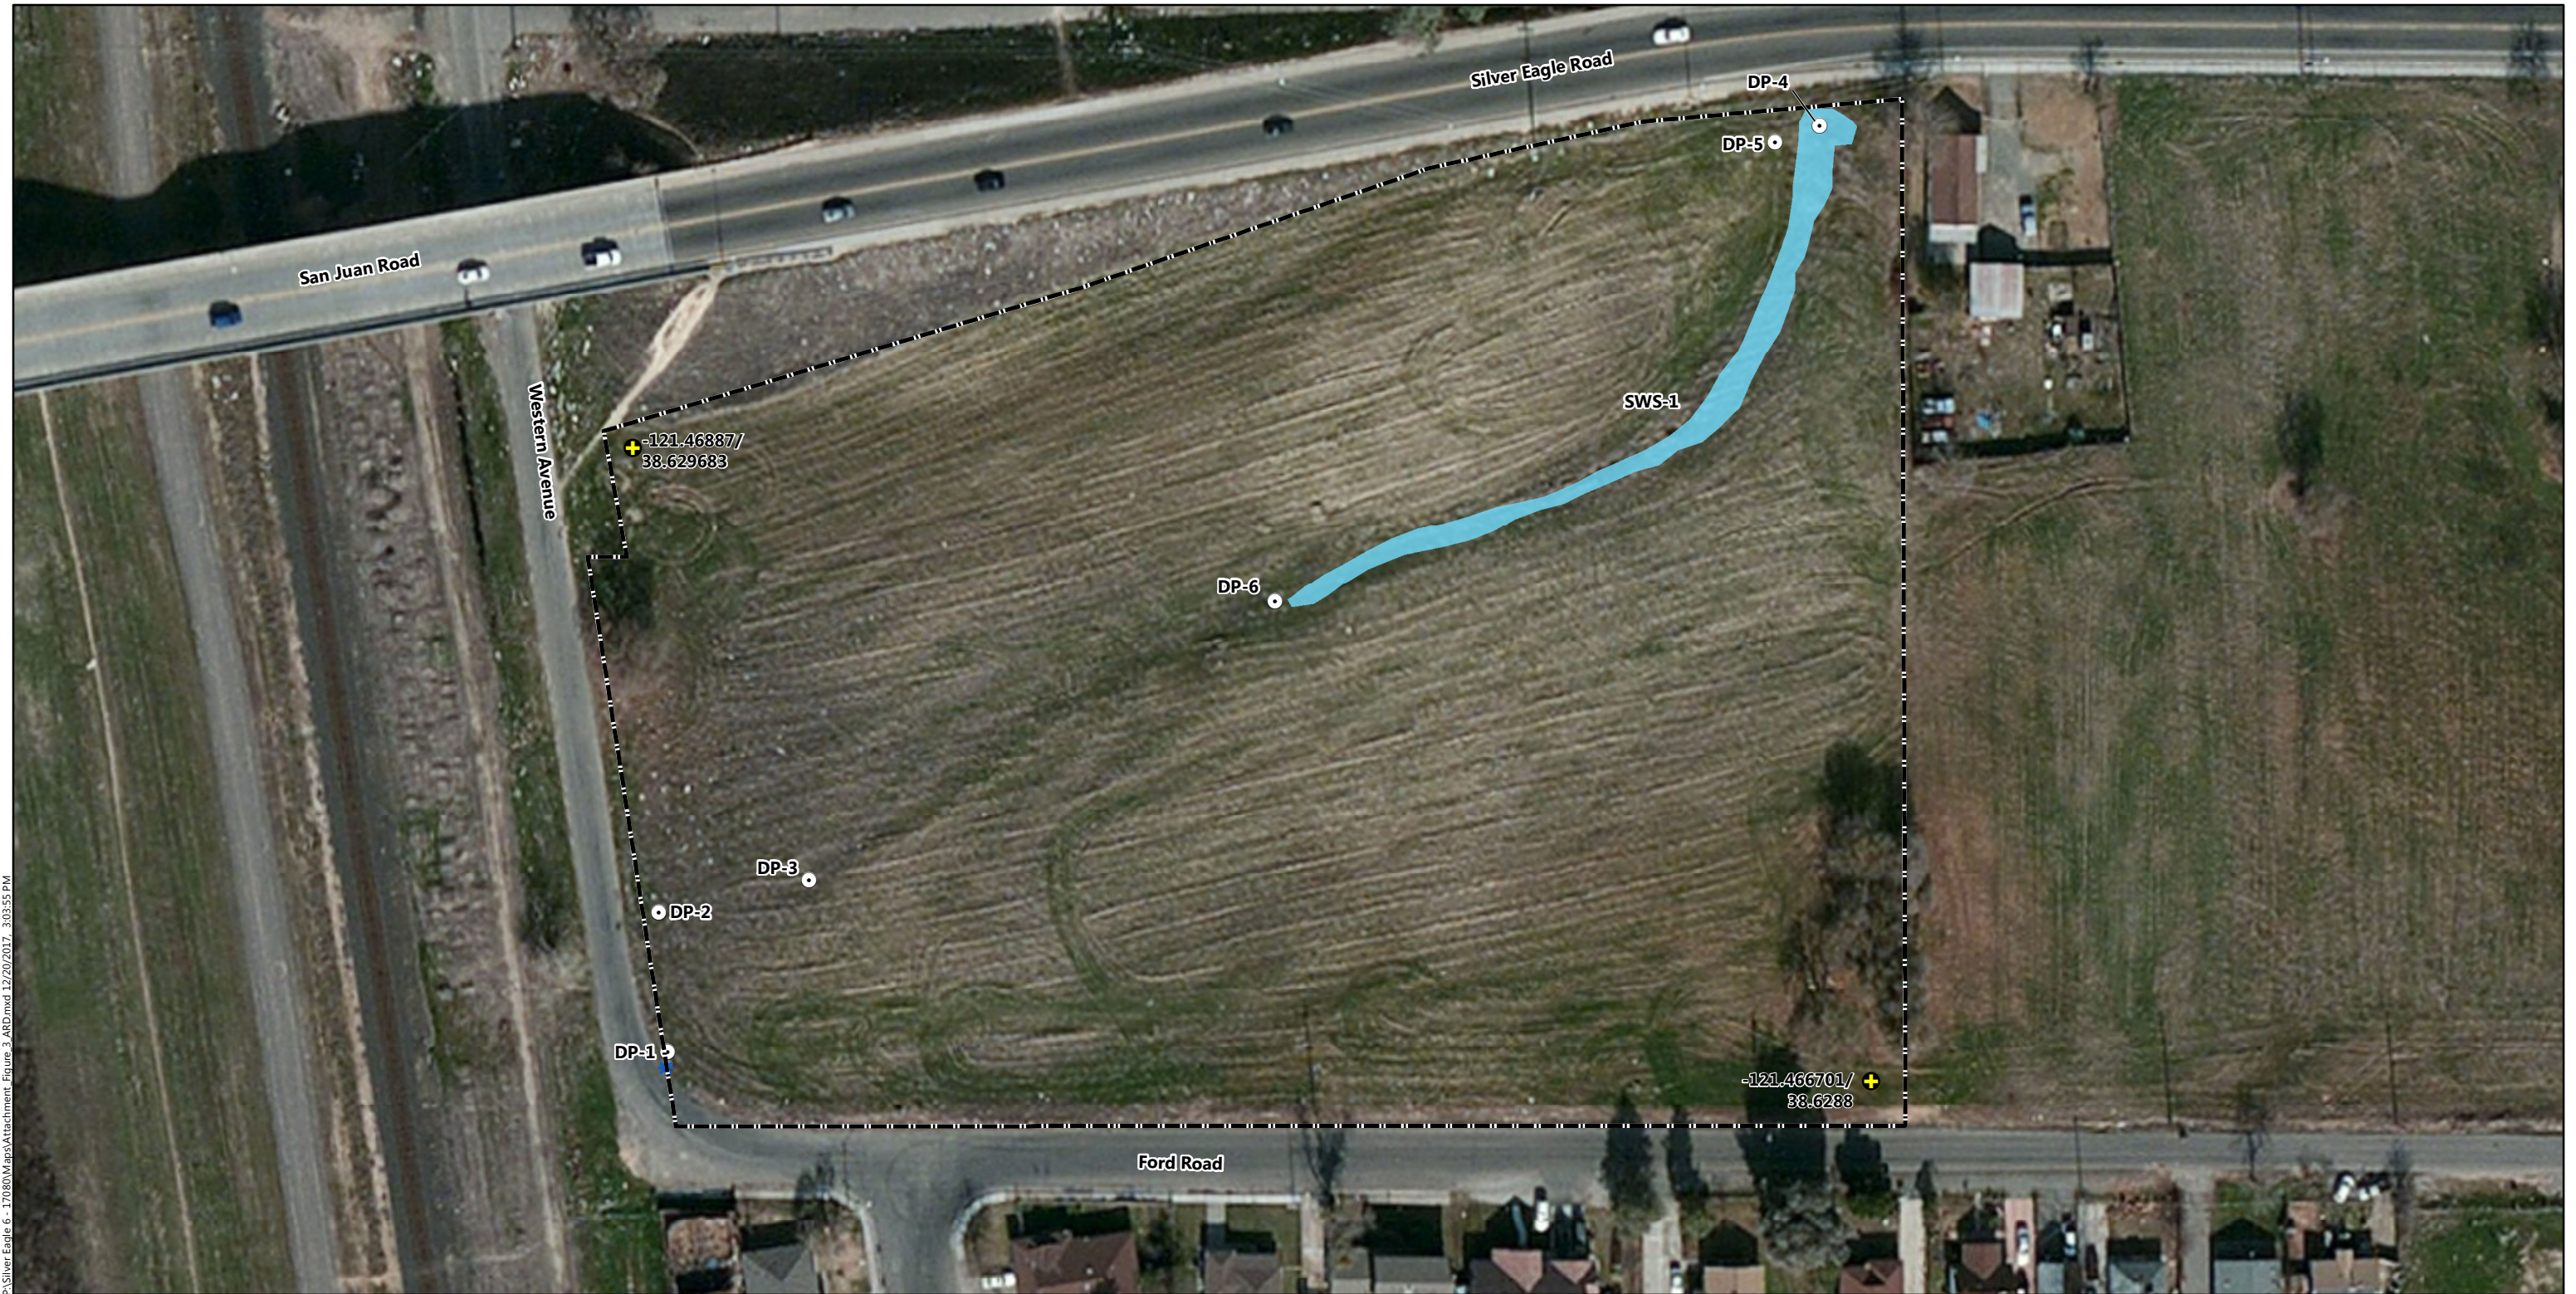
Aquatic Resourced Delineation Map

Only one aquatic resource feature, a 0.111 acre remnant seasonal wetland swale, was delineated within the Study Area. A number of data points were collected due to the presence of a salt crust throughout the entire site and evidence of a historic swale (seasonal wetland swale). Data sheets are included in **Attachment A**, a map of the aquatic resource is included as **Attachment B**, and a list of the plant species observed in the Study Area with their wetland indicator status is included in **Attachment C**. Representative site photographs are included in **Attachment D**. GIS Shapefiles and the *Aquatic Resources Excel Spreadsheet* for the aquatic resource shown on **Attachment B** are included on a CD in **Attachment E**.

The seasonal wetland swale is the remnant of a drainage features that previously flowed from the northeast to the southwest corner through the Study Area. The upstream culvert is partially blocked with sediment and the upstream watershed is limited to roadside drainage from Silver Eagle Road. The feature exhibits seasonal ponding near the upstream culvert and is minimally vegetated with tall nutsedge, Italian rygrass, and hyssop loosestrife. No evidence of scour or ordinary high water mark were observed, and hydrology indicators included biotic crust and oxidized rhyzospheres. Data point DP-04 was representative of the soils within the seasonal wetland swale, which exhibited a depleted matrix (F3) hydric soil indicator. From 0-2 inches soils exhibited a matrix color of 10 yr 4/2. From 2-16 inches soils were clay with a soil matrix of 2.5 5/1 with 5% redox concentration (5 yr 2.5/1) in the matrix.

The applicant is requesting a Preliminary Jurisdictional Determination for the Aquatic Resources Delineation map included as **Attachment B**. A signed statement providing USACE staff accompanied access to the Study Area is included as **Attachment F**.

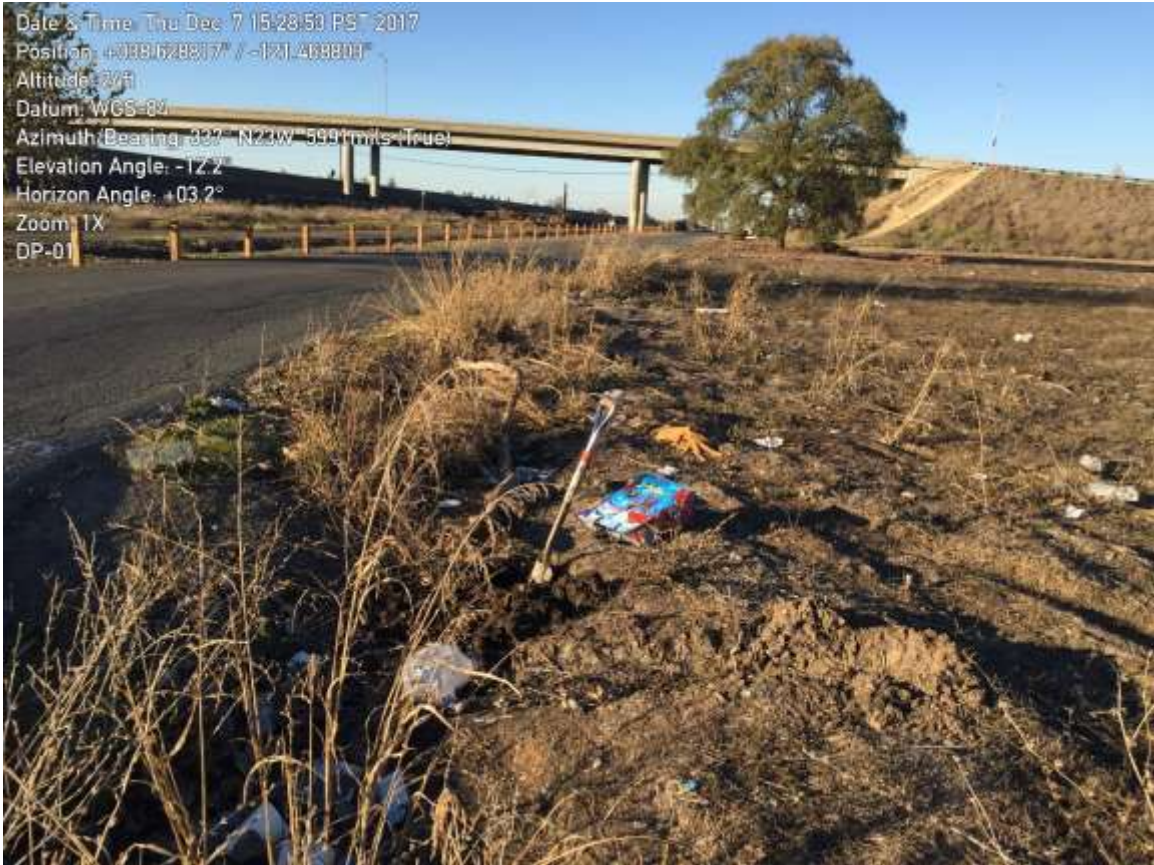
Data Point 1 – 7 December 2017

Remarks: Adjacent to culvert inlet. Inlet is rip-rapped with scattered trash and flows to ditch along railroad tracks. All vegetation on-site is somewhat disturbed and has been disked in the past, however, remnant grass where present was dead and matted indicating growth post disking.

Remarks: *biotic crust may be salt crust

Restrictive Layer (if present): Type: _____ Depth (inches): _____	Hydric Soil Present? Yes _____ No <u> x </u>
Remarks: Rocks, gravel and trash in sample point

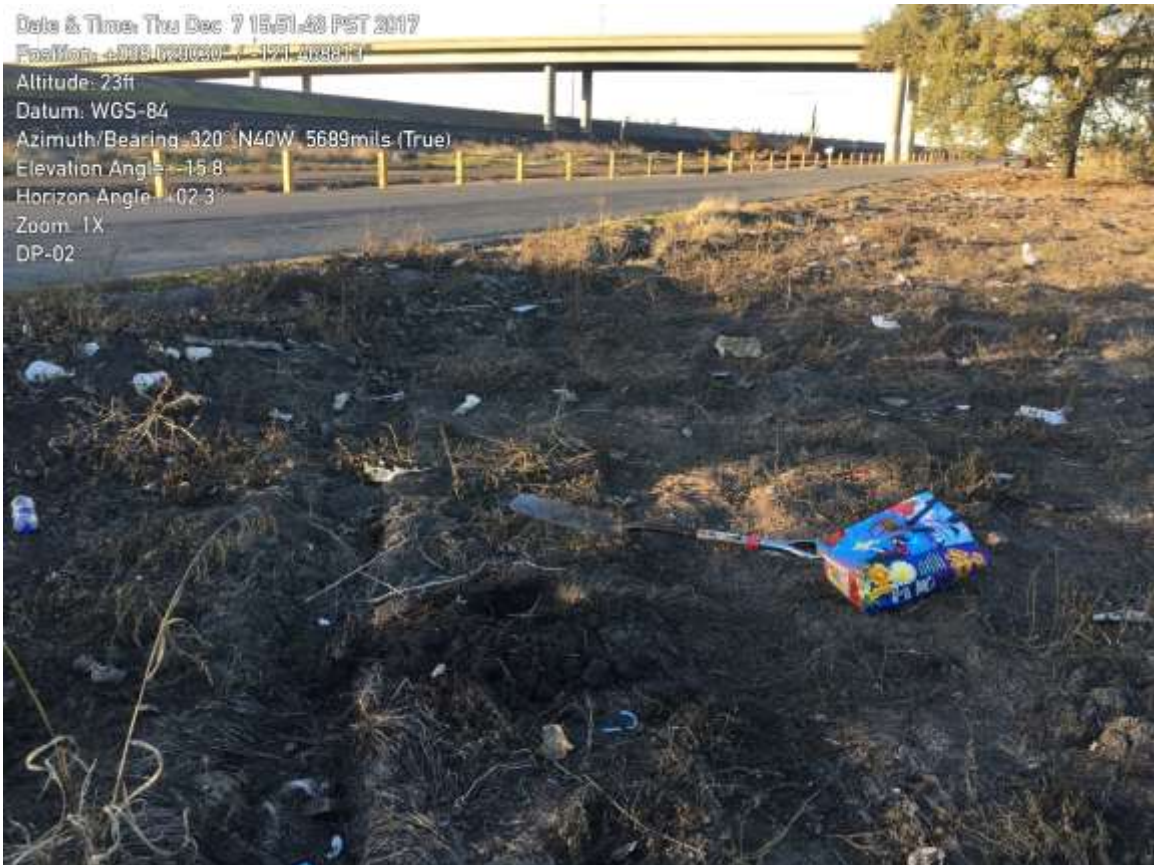
Data Point 2 – 7 December 2017

Remarks: No live grasses, grasses are matted with no remaining seed heads.

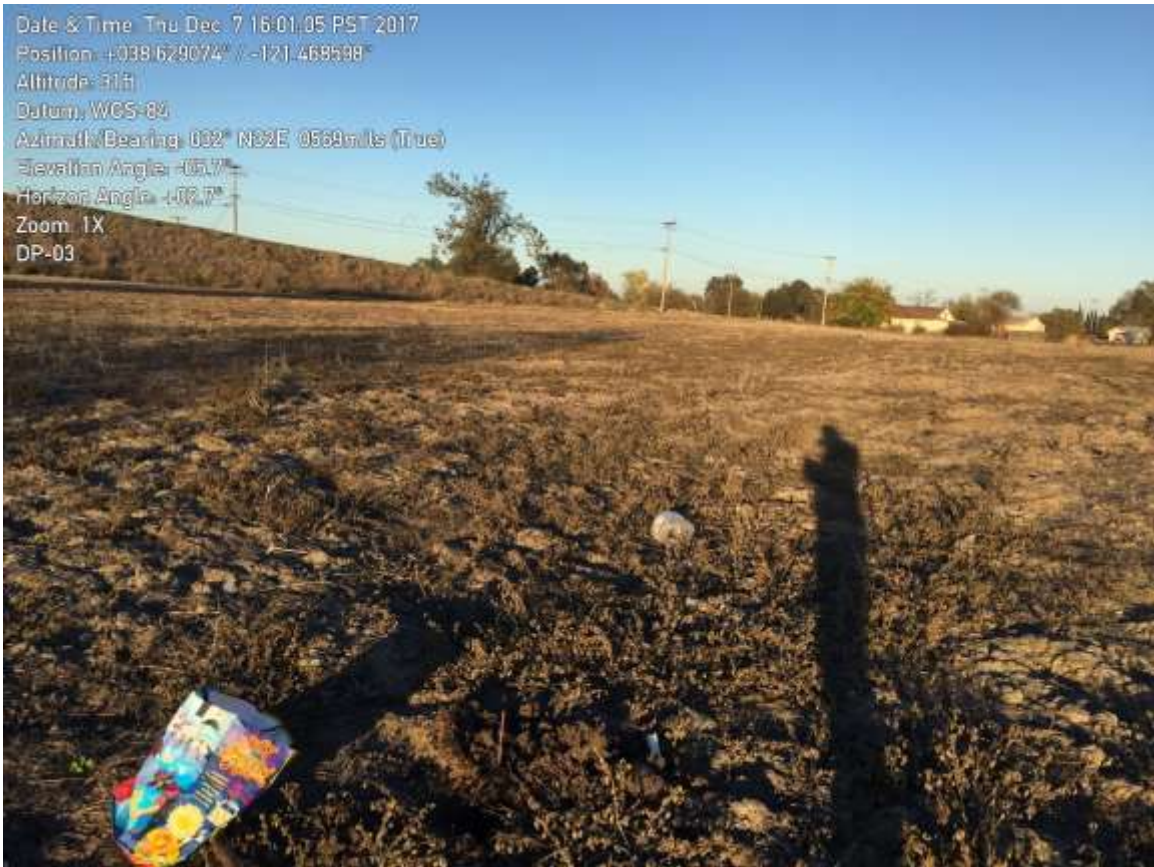
Data Point 3 – 7 December 2017

Depth (inches)	Matrix		Redox Features				Texture	Remarks
	Color (moist)	%	Color (moist)	%	Type ¹	Loc ²		
0-12	10yr 4/1	100					clay

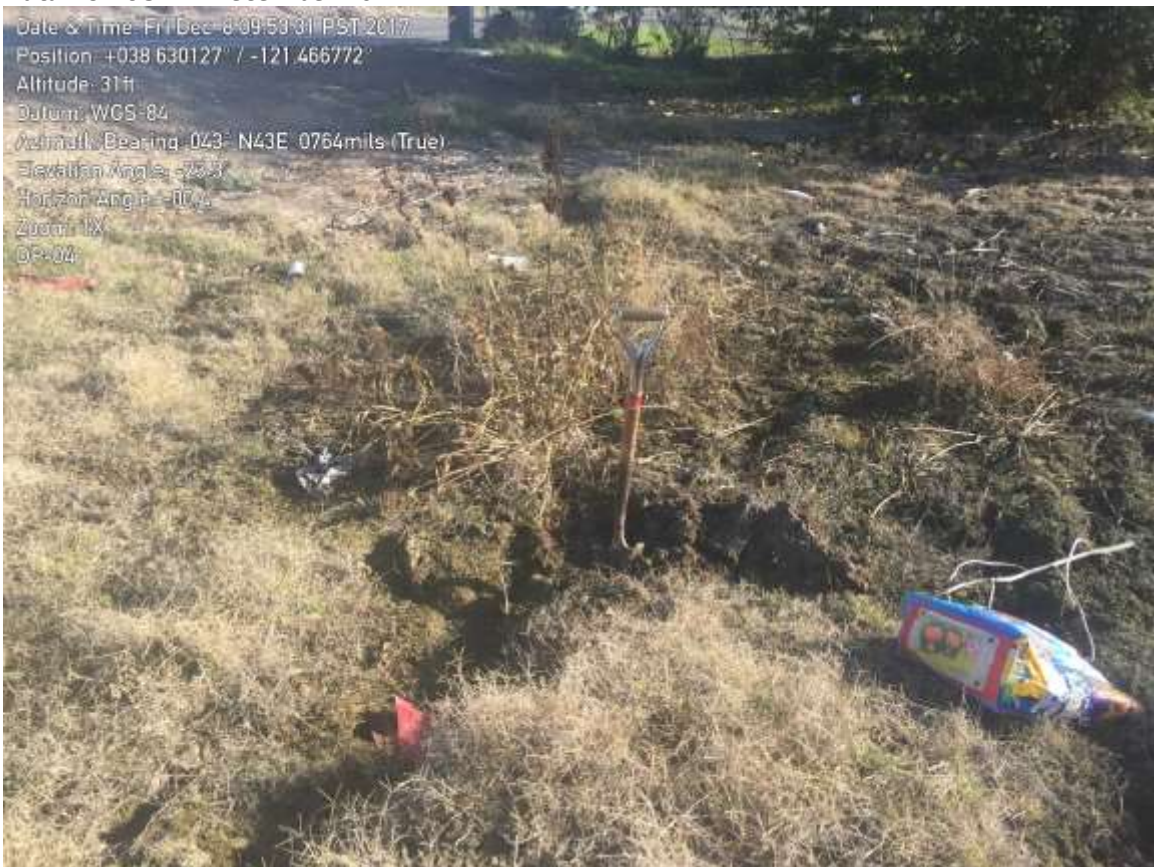
Data Point 4 – 7 December 2017

1. <u>Cyperus eragrostis</u>	<u>25</u>	<u>Y</u>	<u>FACW</u>	
2. <u>Cynodon dactylon</u>	<u>25</u>	<u>Y</u>	<u>FACU</u>	
3. <u>Lythrum hyssopifolium</u>	<u>5</u>	<u>N</u>	<u>OLB</u>

Depth (inches)	Matrix		Redox Features				Texture	Remarks
	Color (moist)	%	Color (moist)	%	Type ¹	Loc ²		
0-2	10 yr 42/	100					Loamy clay	
2-16	2.5 5/1	95	5 yr 2.5/1	5	C	M	Clay

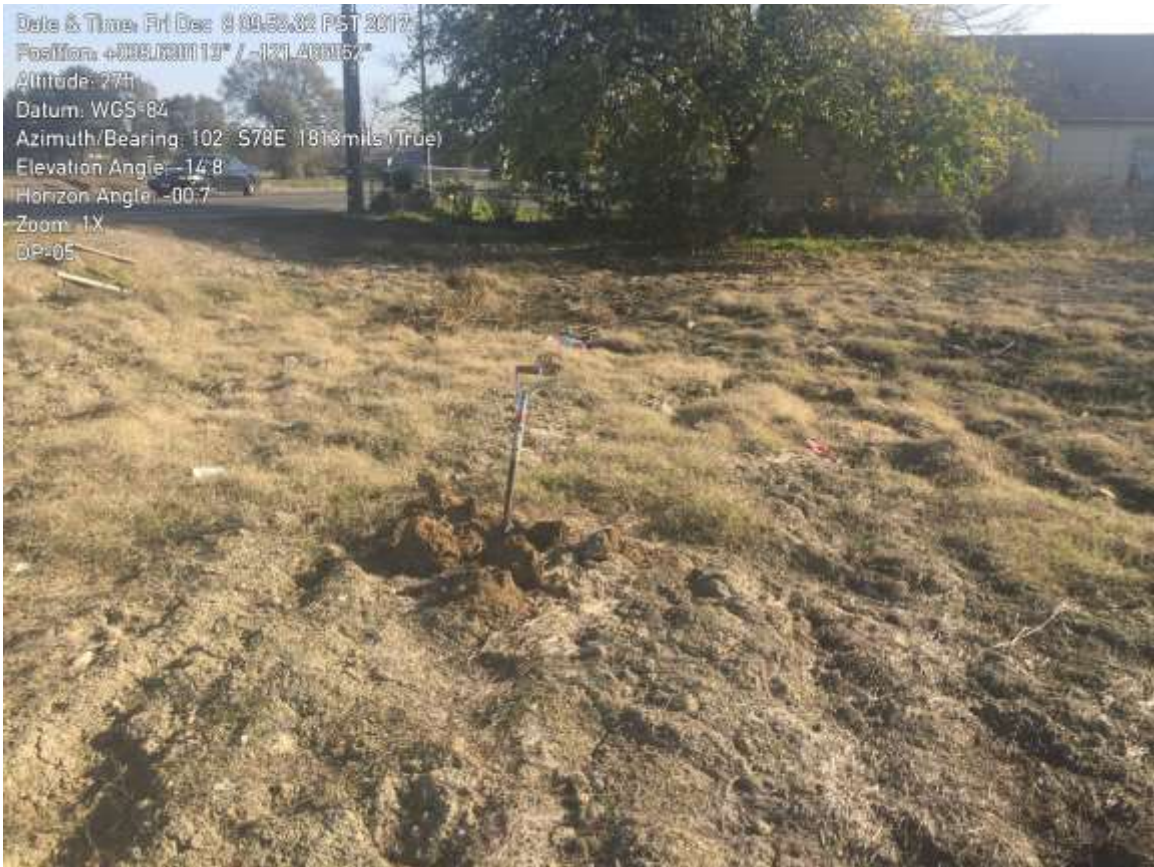
Data Point 5 – 8 December 2017

Depth (inches)	Matrix		Redox Features				Texture	Remarks
	Color (moist)	%	Color (moist)	%	Type ¹	Loc ²		
0-8	10 yr 4/3	100					Clay loam	
8-16	10 yr 3/2	100					Clay loam

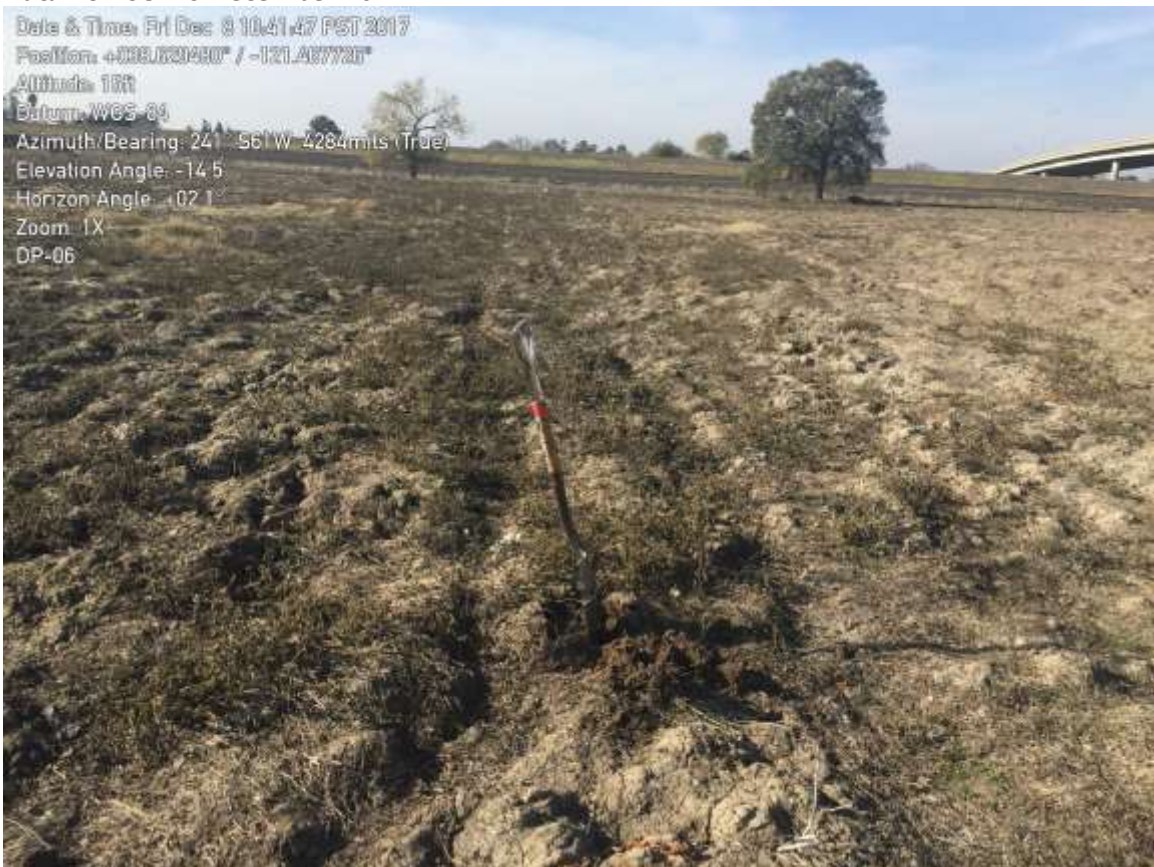
Data Point 6 – 8 December 2017

Depth (inches)	Matrix		Redox Features				Texture	Remarks
	Color (moist)	%	Color (moist)	%	Type ¹	Loc ²		
0-8	10 yr 3/2	100					Clay loam	
8-16	10 yr 4/1	100					Loamy clay	rocks/asphalt chunks
