Project No. S9843-05-01  
December 6, 2013

Subject: PRELIMINARY GEOTECHNICAL EVALUATION  
SILVER EAGLE PROPERTY– WESTERN AVENUE AT FORD ROAD  
SACRAMENTO COUNTY, CALIFORNIA

Silver Eagle Property

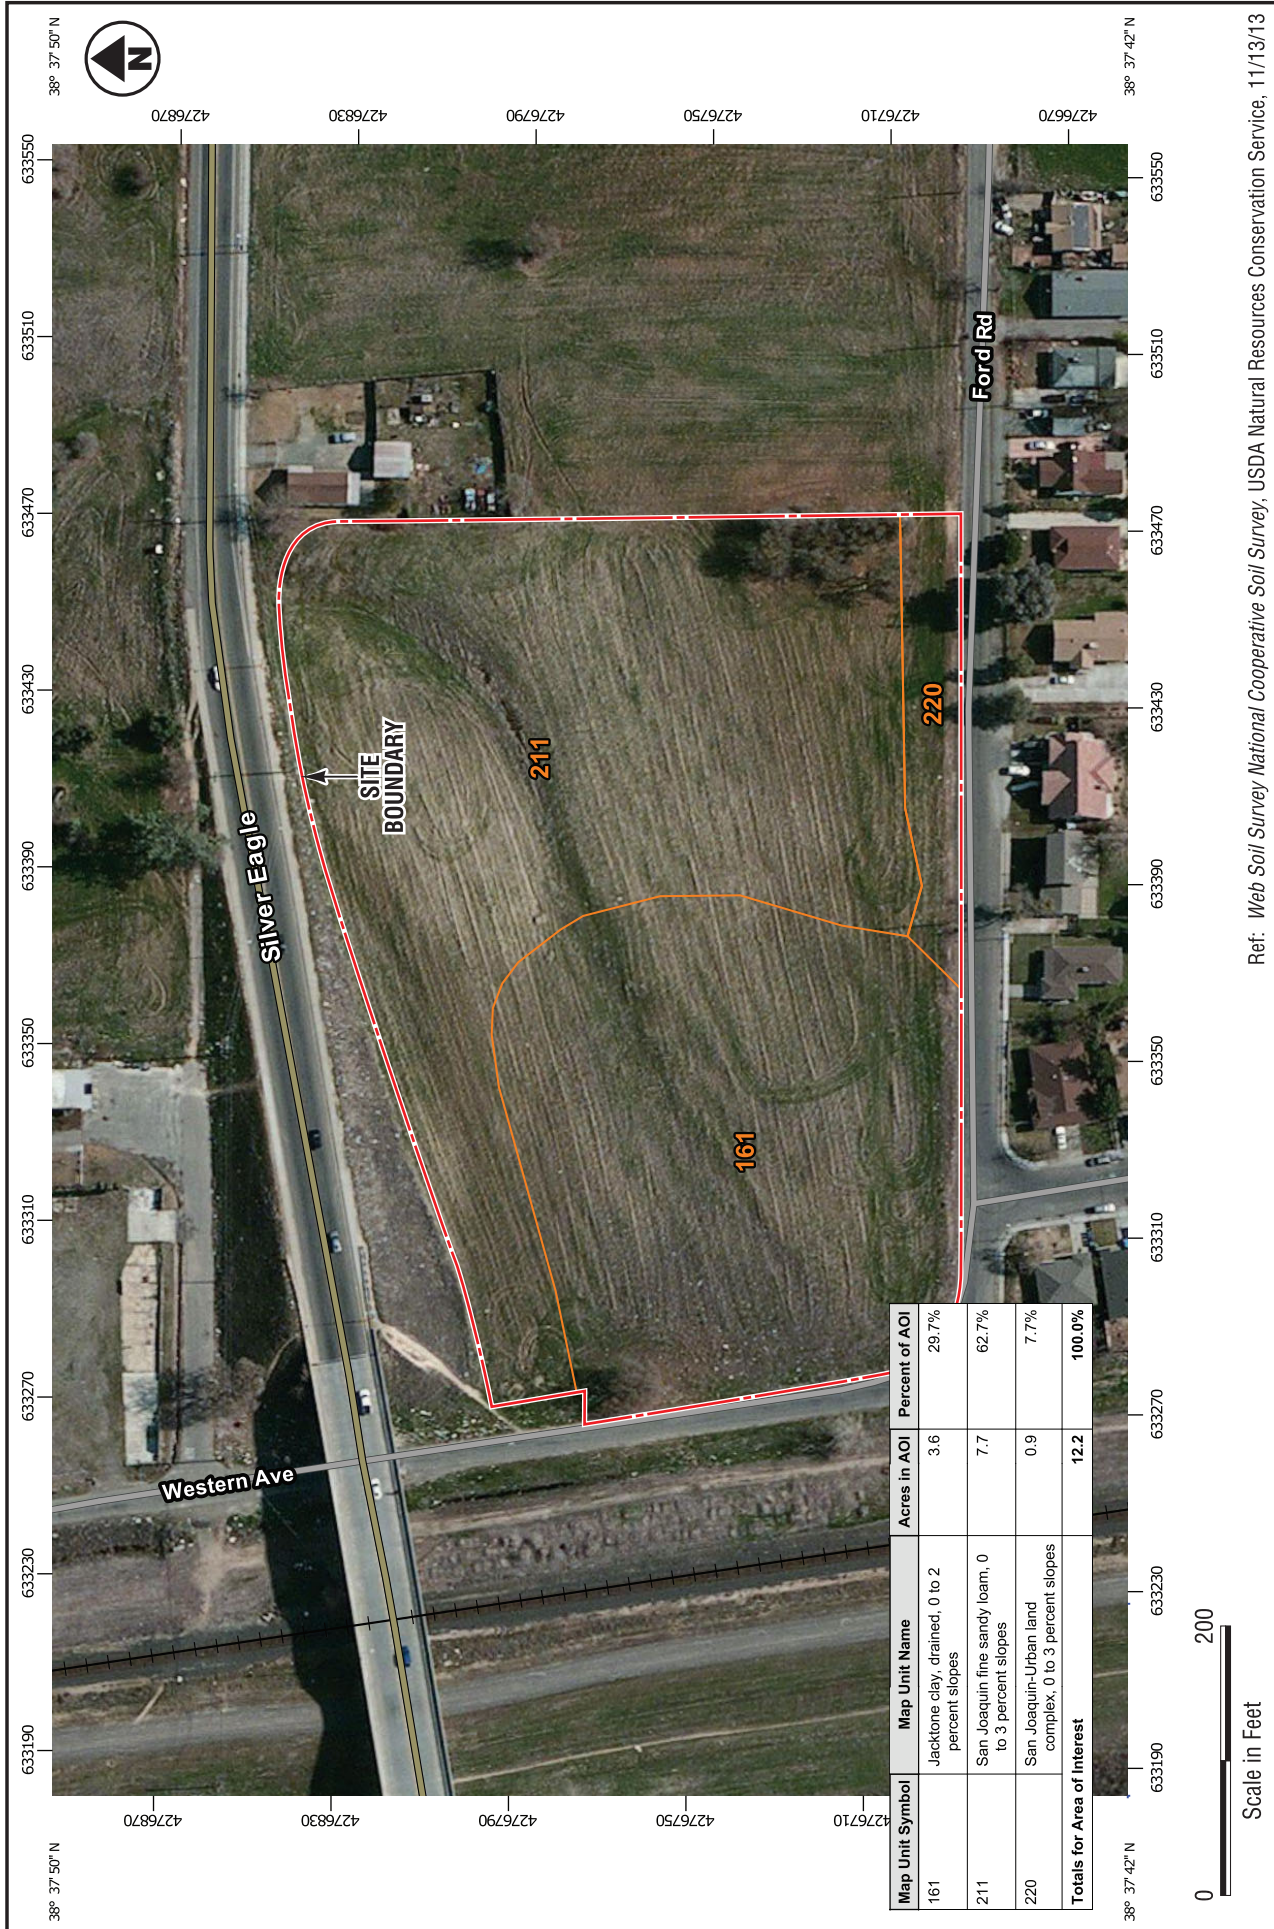
**SOIL MAP**

The approximate lateral extents of these soil units are shown on the Soil Map, Figure 5. As shown on Figure 5, the *San Joaquin fine sandy loam* soil unit covers the majority of the site with the remainder consisting of *Jacktone Clay* soil and *San Joaquin-Urban land complex*.

Map Unit Symbol	Map Unit Name	Acres in AOI	Percent of AOI
161	Jackstone clay, drained, 0 to 2 percent slopes	3.6	29.7%
211	San Joaquin fine sandy loam, 0 to 3 percent slopes	7.7	62.7%
220	San Joaquin-Urban land complex, 0 to 3 percent slopes	0.9	7.7%
<b>Totals for Area of Interest</b>		<b>12.2</b>	<b>100.0%</b>

The following geologic and soil conditions are based on our review of the referenced geologic literature and our experience in the area. A geologic map of the site and near vicinity is presented as Figure 4. A soil map based on the United States Department of Agriculture (USDA) *Web Soil Survey* is presented as Figure 5.
