Draft
**Existing Conditions and Assessment Report
and Stream Corridor Management Plan
for Arcade Creek, Sacramento County, California**

October 2007

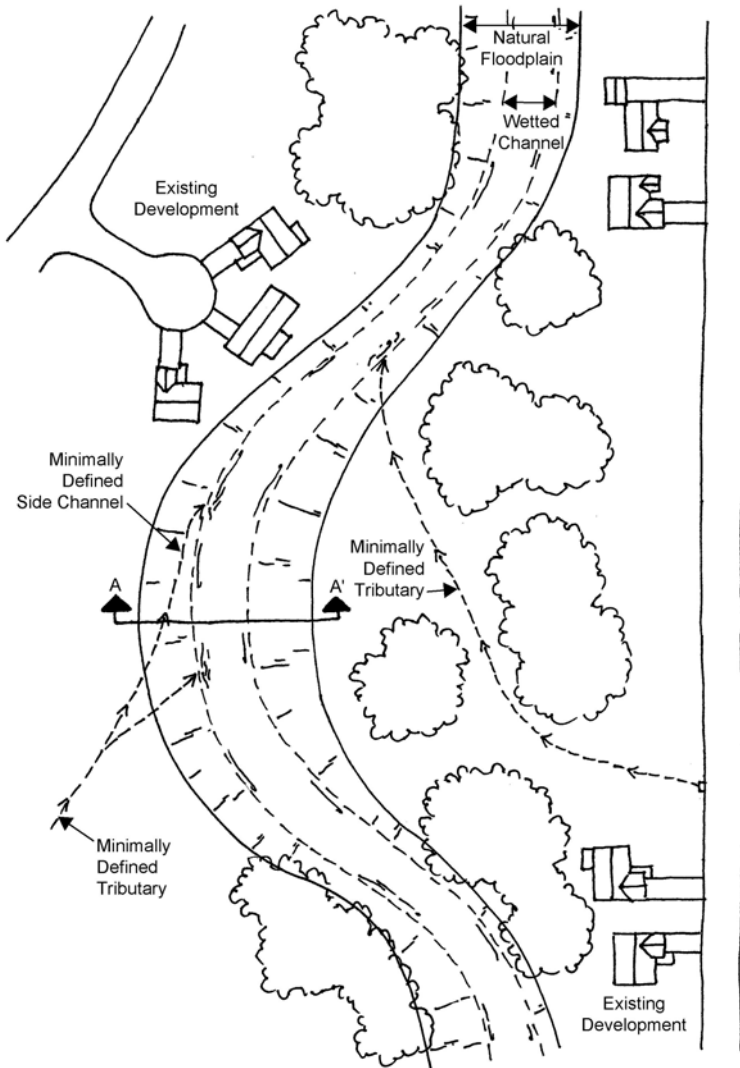
Current Floodplain Scenario

The figures below illustrate current and desired conditions for improving floodplain function.

Regarding the manner in which the stream channel is hydrologically connected to the floodplain (i.e., the degree of channel incision), grading back (i.e., decreasing the slope of) cutbanks and creating point bars and terraces opposite of the cutbanks would allow for better hydraulic connectivity between the channel and the floodplain, promote channel stability, and improve ecological functions. For secondary channel creation and/or enhancement, vegetation removal and excavation would be the primary associated activities. A primary path for the secondary channel would need to be defined, then cleared accordingly. For tributary confluences, bank stabilization activities would be necessary.

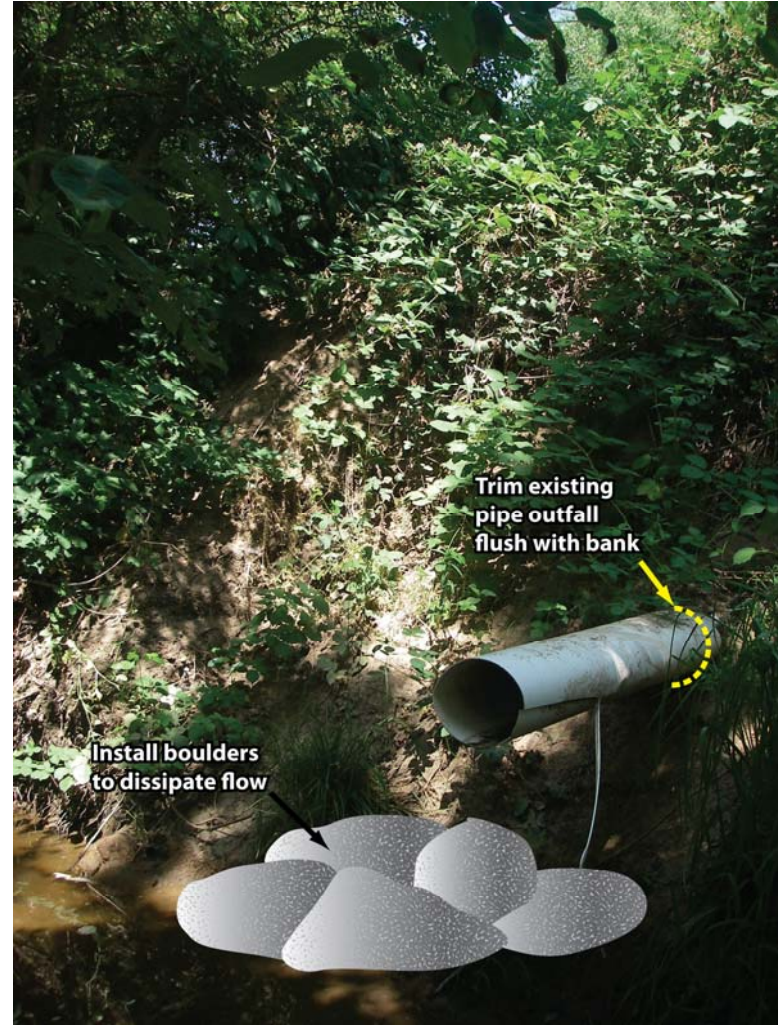
Proposed Improvement

Eroding Pipe on Right Bank (Reach 12)

The existing pipe outfall would be trimmed back to either allow for an extension of the pipe outfall in the downward direction (if the pipe outfall exceeds more than a few feet in height) or to lay flush with the bank. In both cases, boulders would be installed in the channel bed against the bank to dissipate the energy of the water exiting the pipe outfall. If the pipe extension method were used, then the extension would need to be properly secured to the bank with the outlet located approximately 2 feet above the low-flow water surface. The outlet would also be supported by the boulders placed in the channel bed.

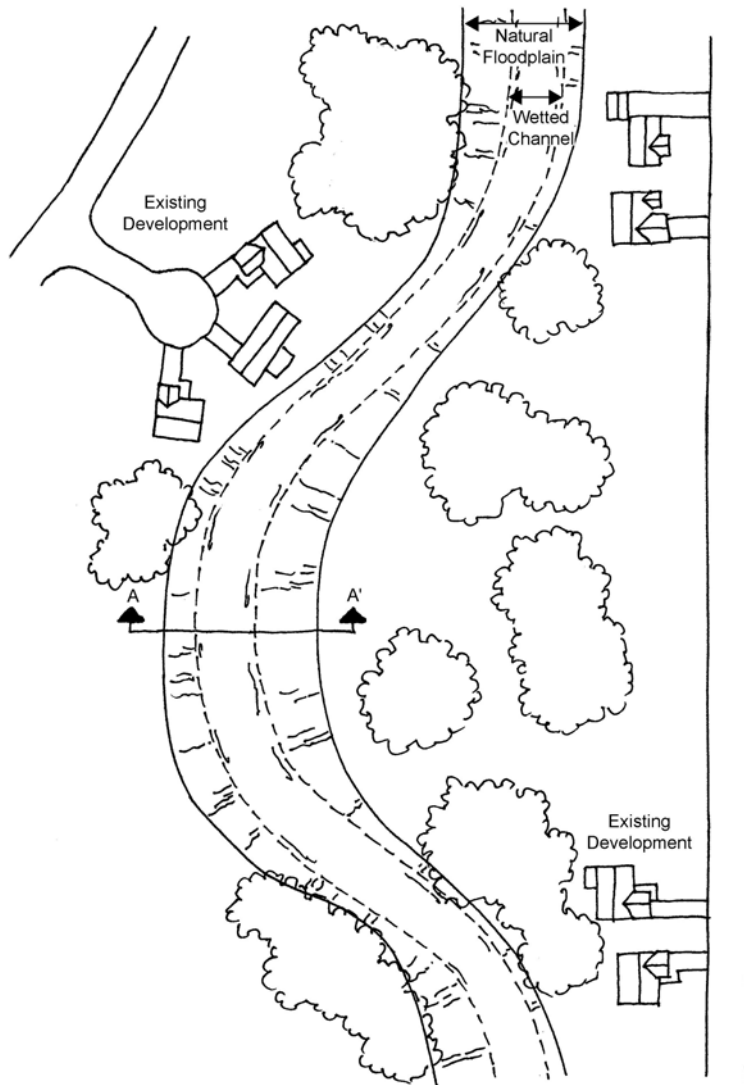
Current Channel Configuration

The figures below illustrate current and desired conditions for channel reconfiguration in Reach 17 and Reach 18.

In general, reconfiguring the channel involves physically redirecting part or all of the channel from its' current path. The planform of the channel changes and stream banks and the floodplain are affected. By increasing planform sinuosity (constructing more meanders) and creating point bars and terraces, the conveyance capacity of the channel increases and the erosive energy of flow decreases. Furthermore, decreasing the slope of the surrounding banks, as well as increasing the distance between the channel, its banks, and surrounding structures protects property and infrastructure from flooding and associated erosion.
