ARCADE CREEK FEASIBILITY STUDY

Prepared for:

Department of Parks and Recreation
City of Sacramento
1023 J Street, Room 200
Sacramento, California

November 15, 2002

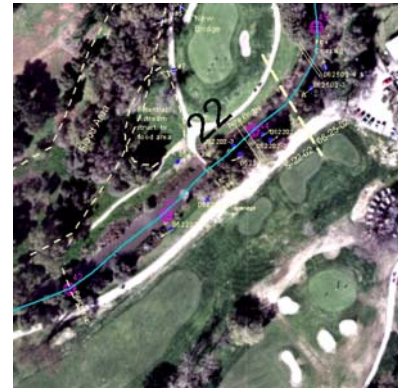
Photographs: 052202: 1-10

Stream structure is poor in this reach as it contains only one large pool. The streambed is composed mostly of silt with some organic debris. The bankfull width is slightly under 1.5 times the observed width. The width of the available floodplain is 100 feet. The water is brown and turbid with a somewhat organic odor. Water velocity is a very low .5 feet per second. Channel canopy cover is 30%.

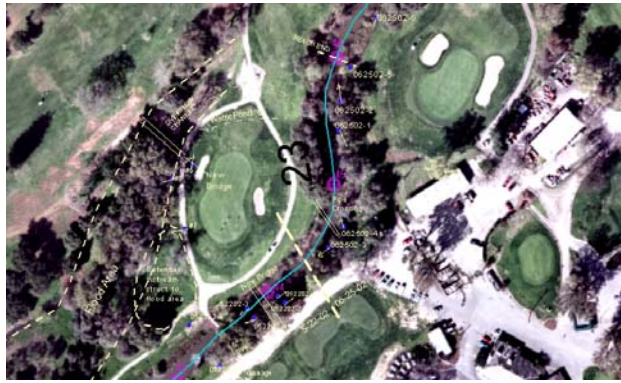
Photographs: 062502: 1-4

Stream structure is poor in this reach due to low sinuosity and being composed of a single large pool with no riffles. The streambed is primarily composed of silt with lots of organic debris. The bankfull width is 1.3 times the observed width. The left bank is in good condition and the right bank in moderate condition but both are a little cut. The water is brown. The available floodplain is narrow at only 39 feet. Woody debris and a pipe crossing the stream partially obstruct the flow of water. Channel canopy cover is moderate at 45%.

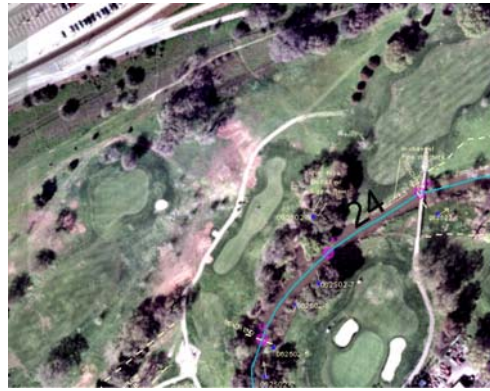
Photographs: 062502: 5-7, 9

Overall this reach has poor stream structure with low sinuosity and no riffles or runs. The bankfull width is only slightly larger than the observed width of the creek. There are erosion problems on the left bank directly across from the outfall. This part of the bank has been reinforced with concrete. There is some woody debris in the channel along with a rusty pipe. The available floodplain is 51 feet wide. The creek is slow moving and receives lots of sun due to the sparse channel canopy cover (5%).

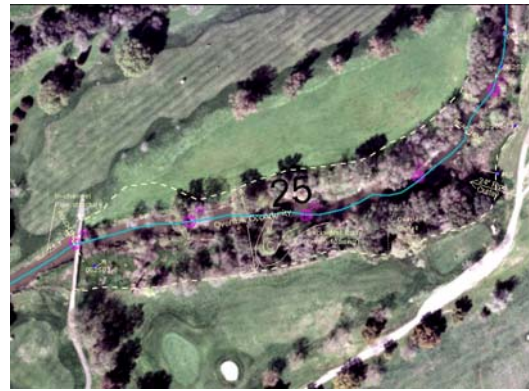
Photographs: 062502: 8, 10

The stream channel has low sinuosity in this reach. The streambed is composed primarily of silt with some organic debris. The bankfull width is 1.5 times the observed width. Both banks are in good condition. A bridge partially obstructs water flow along with some large woody debris. Ninety feet of floodplain are available. Channel canopy cover is poor at only 15%. Overall stream structure is poor, but typical, being formed of one large continuous pool.

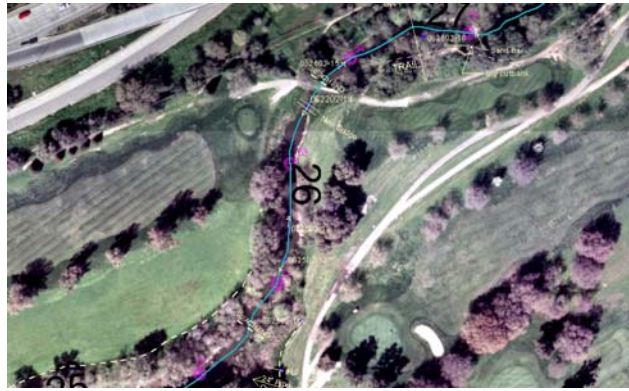
Photographs: 062502: 11-14

The stream channel has low sinuosity in this reach. Silt composes the streambed almost exclusively, with some organic debris. The bankfull width is only slightly wider than the observed stream width. Overall bank condition is fair with some bank cut and some armoring already present. Some woody debris obstructs the stream. The available floodplain is 63 feet. Channel canopy cover is a very low 10%. This reach is composed of one large pool and so has poor stream structure.

Riparian vegetation is poor on both the left and right banks with only a 10% canopy cover. This is primarily due to the fact that the width of the riparian vegetation is only 8 feet and there are many bare spots where the fairways cross the creek. Oregon Ash and Interior Live Oak were noted on the left bank. The right bank vegetation is composed of Catalpa, Oregon Ash, and Blue Oak.

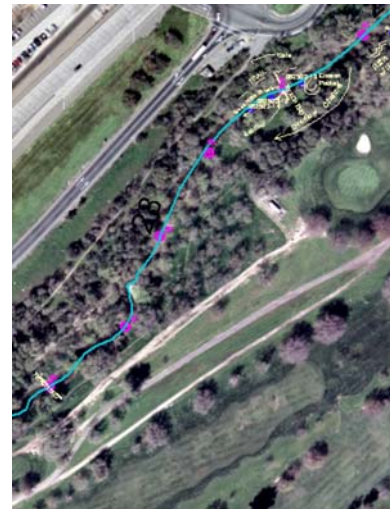
Photographs: 062502: 17-18

The stream channel is highly sinuous in this reach. Silt, with some organic debris and sand, forms the streambed. The bankfull width is less than 1.5 times the observed width. Both the left and right banks have large cut sections. Tires, woody debris and sand bars all form obstructions to water flow in the stream channel. One hundred and eleven feet are available for the floodplain. The channel has good canopy cover of 78% and water moves slowly at .7 feet per second. There are no riffles in this reach and thus stream structure is poor.

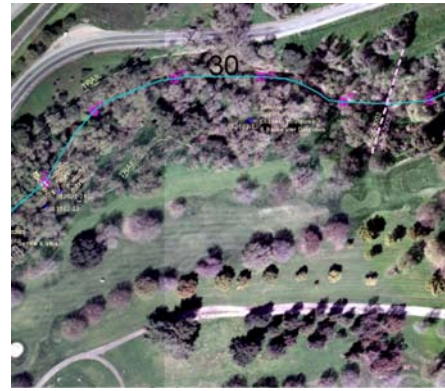
Photographs: 062502: 21, 23

The stream channel in this reach has moderate sinuosity. The streambed is made up mostly of silt with some organic debris and a slight amount of sand. The bankfull width is only slightly wider than the observed stream width. Both the left and right side of the channel have big cut banks with large root masses. There is some trash and woody debris obstructing the channel. There is no flood plain available. The stream flows at the very slow pace of .5 feet per second under a dense, 90% canopy cover. Stream structure is poor, being composed of a single large pool.

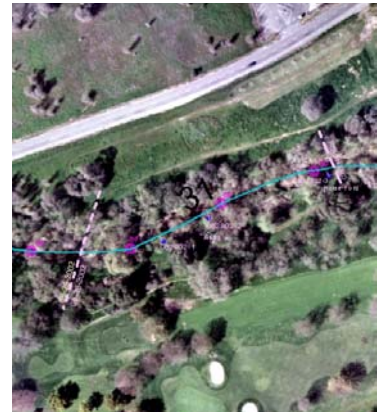
Photographs: 062802: 1-3

The creek channel in this reach has medium sinuosity. The streambed is composed primarily of silt with some sand and organic debris. The bankfull width is only slightly larger than the observed width. Both the left and right banks are cut and eroded. Obstructions include one large downed tree and miscellaneous woody debris. The width of the available floodplain is 222'. The water moves slowly through this reach at .5 feet per second. Canopy cover averages 50% over the channel. Stream structure is very good with four runs in this reach.

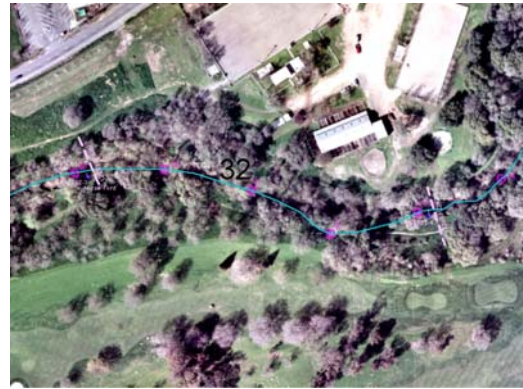
Photographs: 062802-4

This reach's stream channel has low sinuosity. The streambed is composed mainly of silt with some organic debris and sand and a few cobbles. The bankfull width is slightly less than four times the observed width. Both the left and right banks are cut and eroding. There are a couple of snags in the stream channel, potentially obstructing flow. The available floodplain is 120 feet wide. The channel is 35% covered by tree canopy. Stream structure is poor as this reach consists of one large pool.

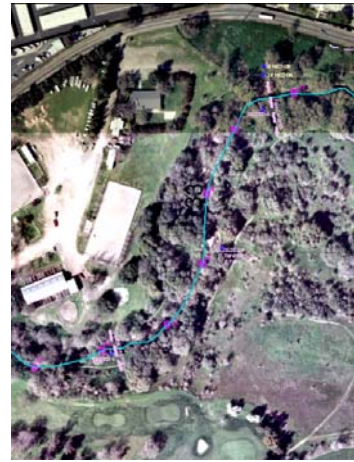
Photographs: 062802: 5-6, 071502: 5-6

The stream channel in this reach has high sinuosity. The streambed is composed primarily of silt with some sand and small amounts of organic debris and gravel. The bankfull width is six times the observed width. Both banks are in fair condition and are cut and incised. There are some sand bars and organic debris obstructing the channel. There is no available floodplain. Water flows quickly at 2 feet per second under 70% canopy cover. Stream structure is excellent with five runs in this reach.

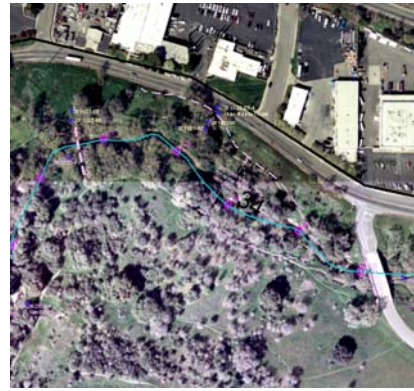
Starting Stationpoint: 77.6
Ending Stationpoint: 82.0
Photographs: 071502: 1-4

The stream channel in this reach has very low sinuosity. The streambed is primarily silt with some organic debris and sand and small amounts of gravel and cobbles. The bankfull width is equal to the observed stream width. The left bank is eroded and cut while the right bank is eroded. A few logs in the water obstruct flows in this reach. There is no floodplain available. Stream velocity is very slow at .5 feet per second. The channel is 60% covered by tree canopy. Stream structure is moderate with two runs in this reach.

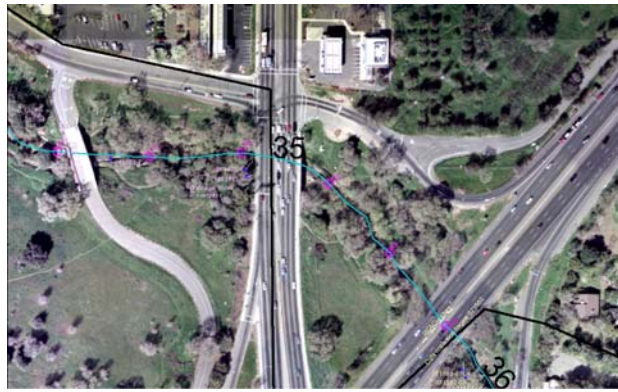
Photographs: 062802: 7-9

The stream channel in this reach has low sinuosity. The streambed is primarily silt with small amounts of organic debris, sand, and gravel. The bankfull width is 7.5 times the observed width. Both the left and right banks are cut, especially near the softball complex entrance. Obstructions in the creekbed consist of snags and other organic debris. The smell of human feces was strong in some areas of the creek. The available floodplain is 300 feet wide. The stream flows slowly at a rate of 1 foot per second. The average channel canopy cover is 40 feet per second. Stream structure is good with three runs in this reach.

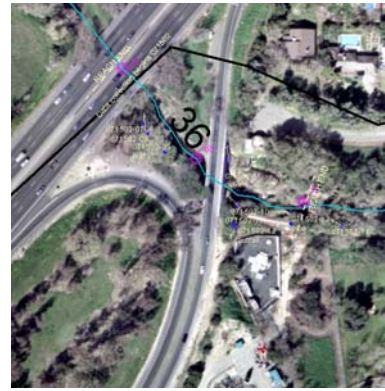
Photographs: 071502: 7-13, 51

Sinuosity is low in this reach's stream channel. The streambed consists primarily of silt with some organic debris and small amounts of sand and gravel. The bankfull width is 3.5 times the observed width. Both banks are in fair condition, being somewhat incised and eroded. There are some trees and branches in the water but no major obstructions. The only distinct odors occurred due to a homeless camp. The available flood plain is 300 feet wide. The stream flows very slowly at .3 feet per second and has a channel canopy cover of 40%. Stream structure is poor, being only one continuous pool.

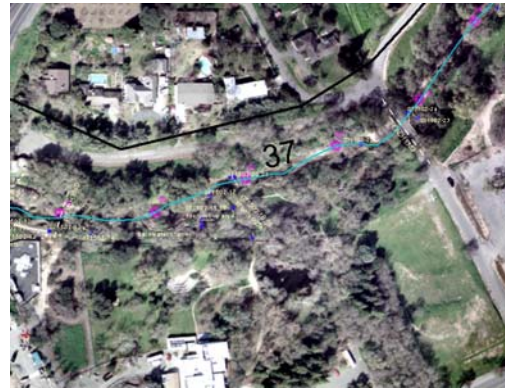
Photographs: 071502: 14-22

The stream channel in this reach has low sinuosity. The streambed consists primarily of silt with small amounts of organic debris and sand and a small amount of gravel. The bankfull width is three times the observed width. Both banks are in fair condition with erosion hazards and some cut. The available floodplain is 180 feet wide. At .5 feet per second the stream velocity is very slow. Channel canopy cover is 40%.

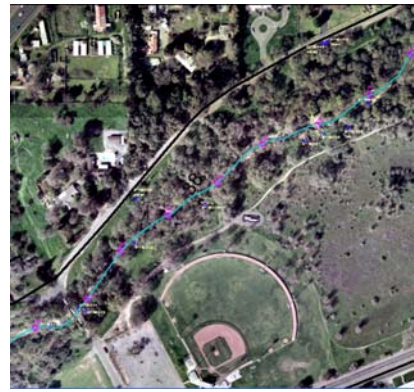
Photographs: 071502: 23-27, 50

The stream channel in this reach has low sinuosity. The streambed consists primarily of silt with some organic debris and sand and small amounts of gravel. The bankfull width is slightly over twice the observed width. Both banks are in poor condition with cut and eroded banks. There are some obstructions in the form of in-channel woody debris. The available floodplain is 600 feet wide. The stream flows slowly at .5 feet per second. Channel canopy cover averages 55%. Stream structure is moderate with two pools and one riffle.

Restoration opportunities include invasive species removal, bank stabilization, removal of structures, creation of overflow and detention structures and trash cleanup. Removing debris from the channel is recommended.

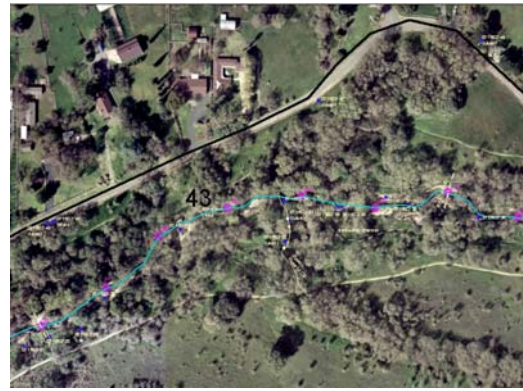
Photographs: 071502: 28-38, 47-49

The stream channel in this reach has a low sinuosity. The streambed consists of mostly silt and gravel with small amounts of organic debris and sand. The bankfull width is 1.3 times the observed width. Both banks are in moderate condition with some cutting and erosion. There are some large snags and sandbars obstructing the channel. The available floodplain is 400 feet wide. Water flows quickly at 1 foot per second in this reach. Channel canopy cover is 30%. Stream structure is good with three runs in the reach.

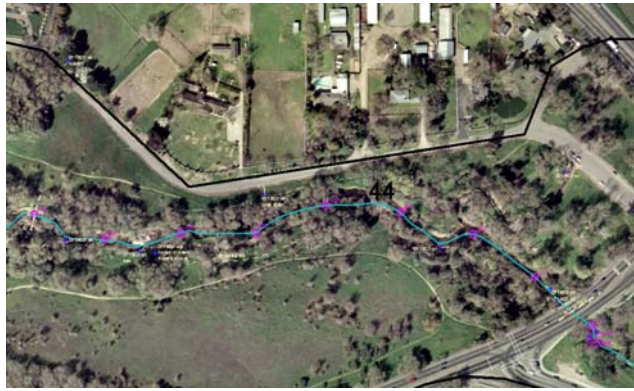
Starting Stationpoint: 104.0
Ending Stationpoint: 112.0
Photographs: 071502-39-46

The stream channel in this reach has a low sinuosity. The streambed consists mostly of silt with some organic debris and small amounts of gravel and sand. The bankfull width is slightly over two times the observed width. Both banks are in poor condition and are incised, cut, and eroding. There are many snags and woody debris obstructing the stream. There is also a large mid-channel bar midway in this reach. The width of the available floodplain is very large at 1200 feet. The stream flows slowly at .5 feet per second. Stream structure is good with three runs in this reach.

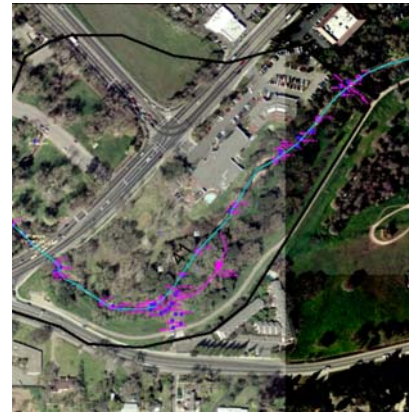
Photographs:080202: 97-124, 106b, 117b

The stream channel in this reach has very low sinuosity, being for the most part straight. Streambed is mostly silt with some streambed organic debris but no sand, gravel, cobbles, or rocks. Bankfull width is ten times the observed width. Overall bank condition is good but at the time of observation serious erosion was occurring at a pump station on the left bank. Work in the area has since been observed, so the damage may have been repaired. A garlic-like odor was noted during the site visit. Obstructions in the channel include a beaver dam type structure and a concrete structure. There is a dry channel running along part of this reach. The available floodplain reached a width of 150 feet. Stream velocity is very low at .2 feet per second and channel canopy cover is 95%. Stream structure is poor with no riffles occurring in this reach.
